# Incident review on a major NPT event during casing makeup

DAN DICKSON

APRIL 12, 2024

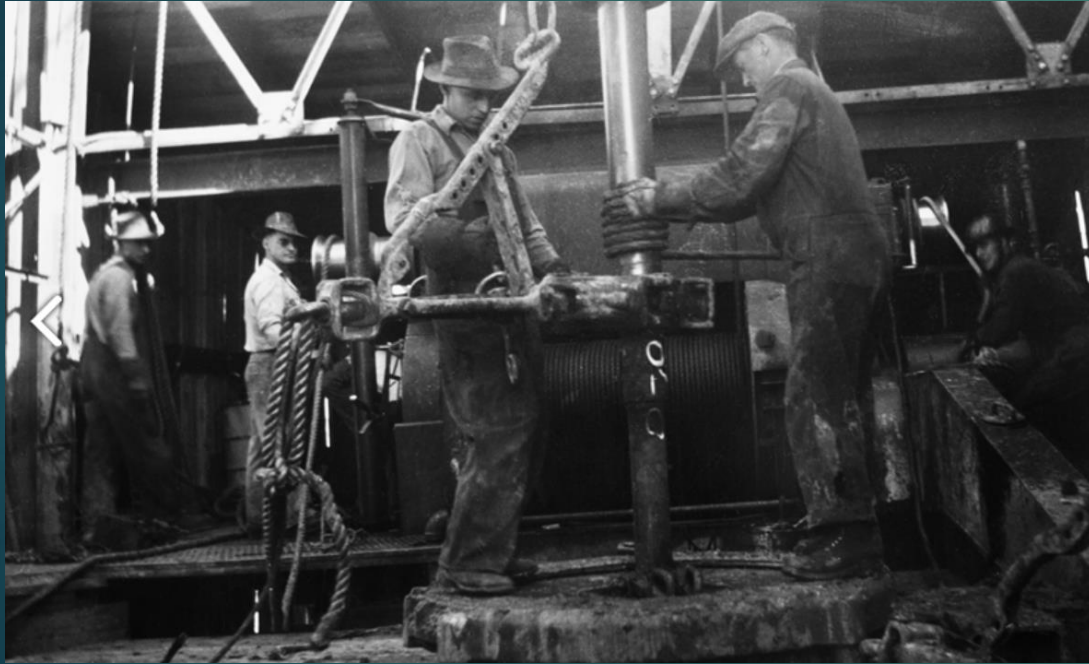
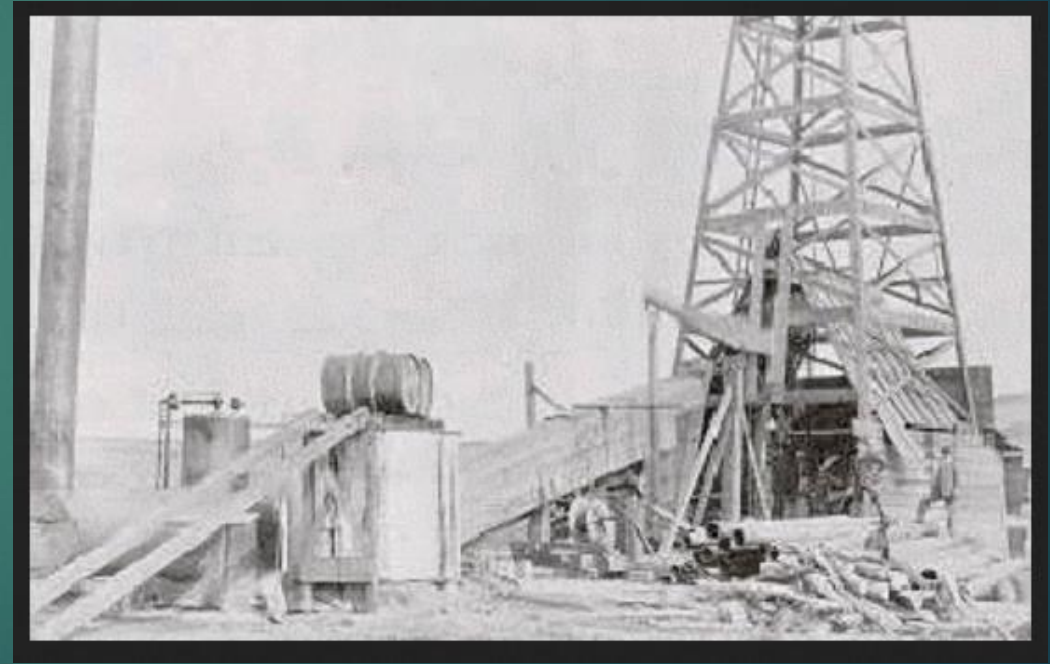
First used to stop formations from collapsing into the wellbore

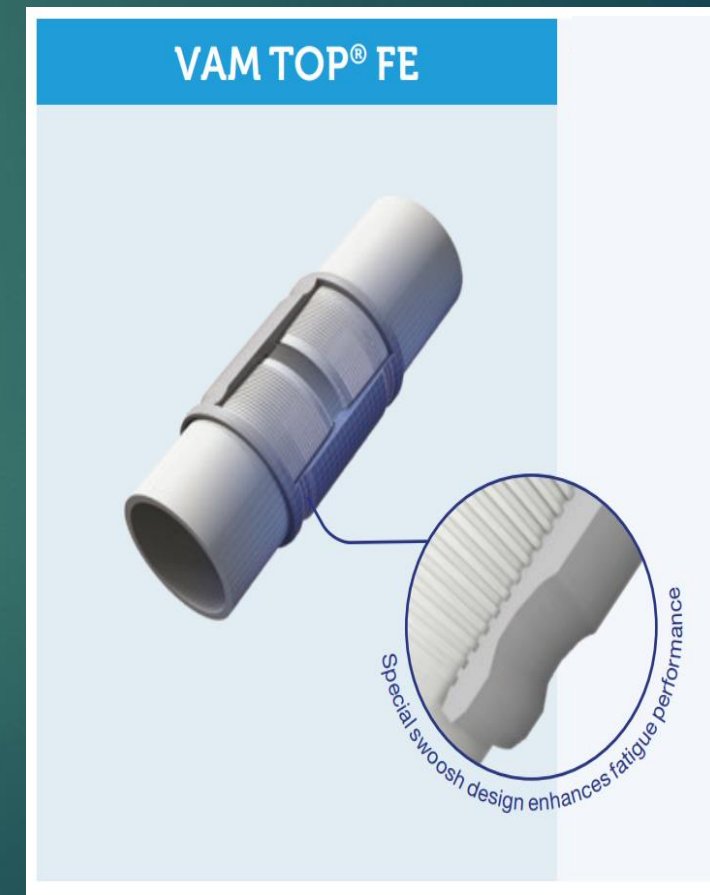
From VAM website: <https://solutions.vallourec.com/oil-gas/octg/products/connections/>

“Premium” threads have been developed that are gas-tight and have a seal to maintain pressure integrity:

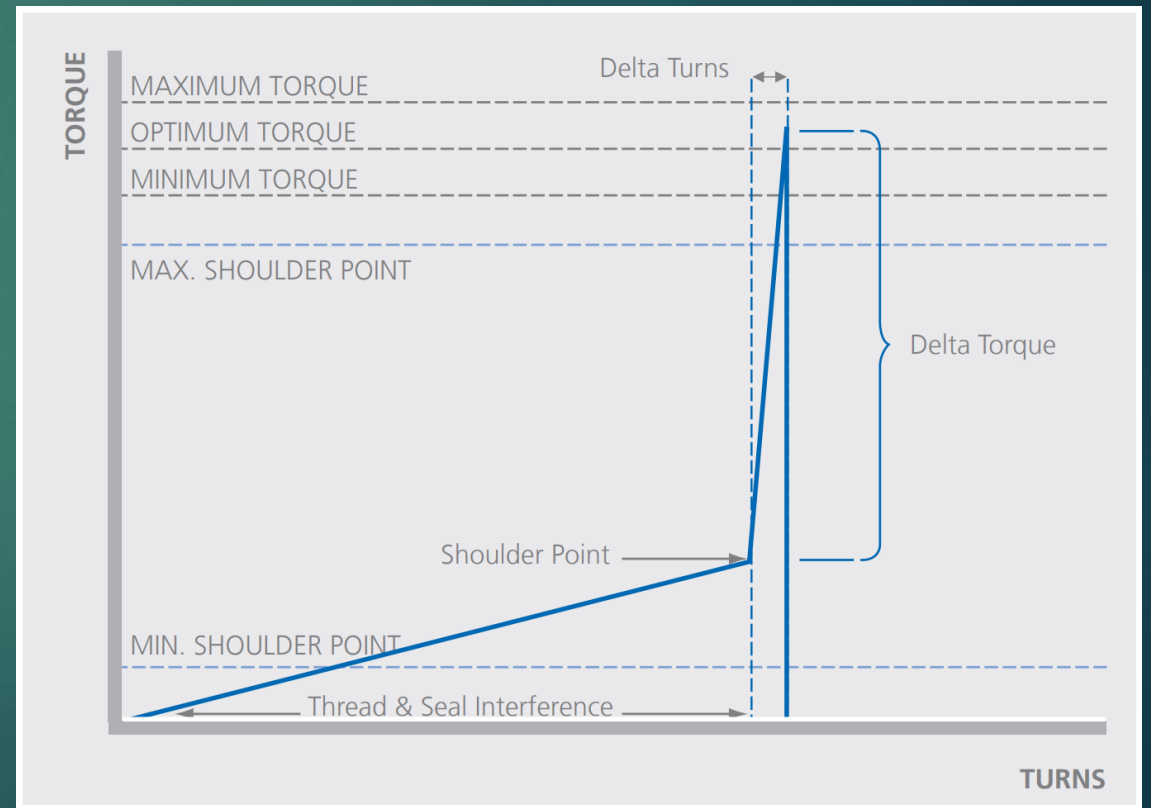
“Premium” threads have two distinct torque profiles to be made up properly:

- 1) Thread Make up, and
- 2) Shoulder (Seal) engagement

This can be seen on a torque vs. turns chart:

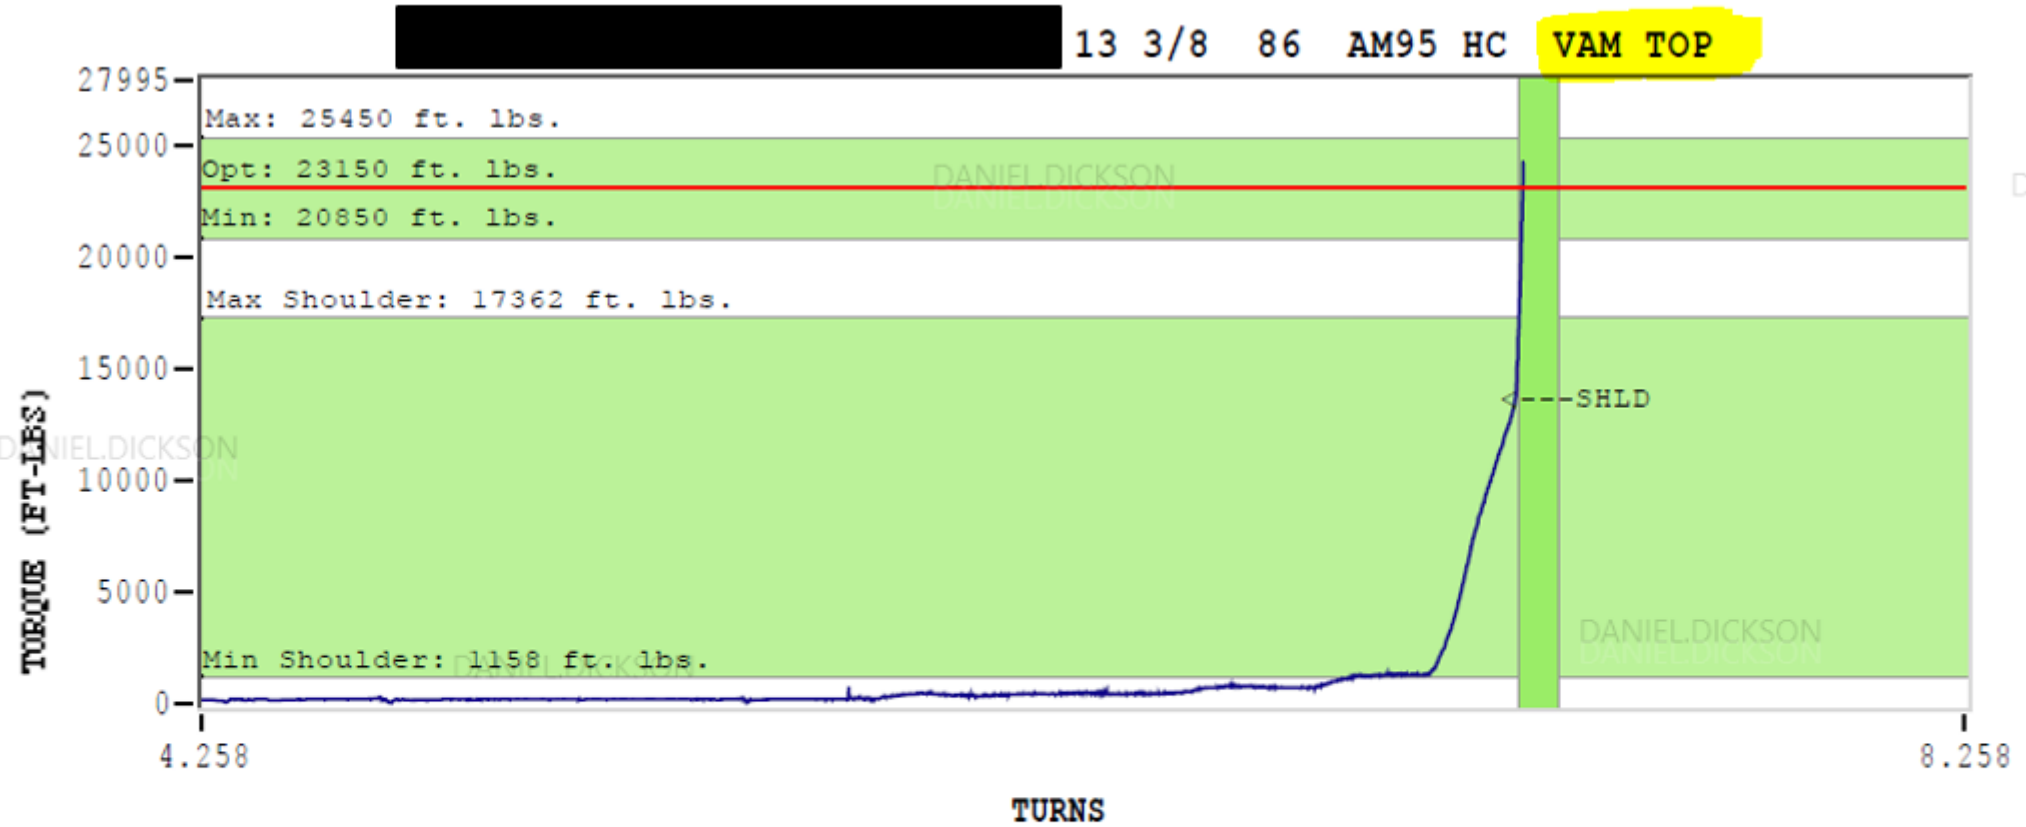
# Actual VAM TOP torque chart – perfect

TIME OF MAKE UP :	06:05 AM	DATE OF MAKE UP :	06/JAN/2023
MAXIMUM TORQUE :	24331 FT-LBS	MAXIMUM TURNS :	7.258 TURNS
SHOULDER TORQUE :	13326 FT-LBS	SHOULDER TURNS :	7.236 TURNS
DELTA TORQUE :	11005 FT-LBS	DELTA TURNS :	0.022 TURNS
FILE NUMBER :	----->> 016	JOINT STATUS :	ACCEPT

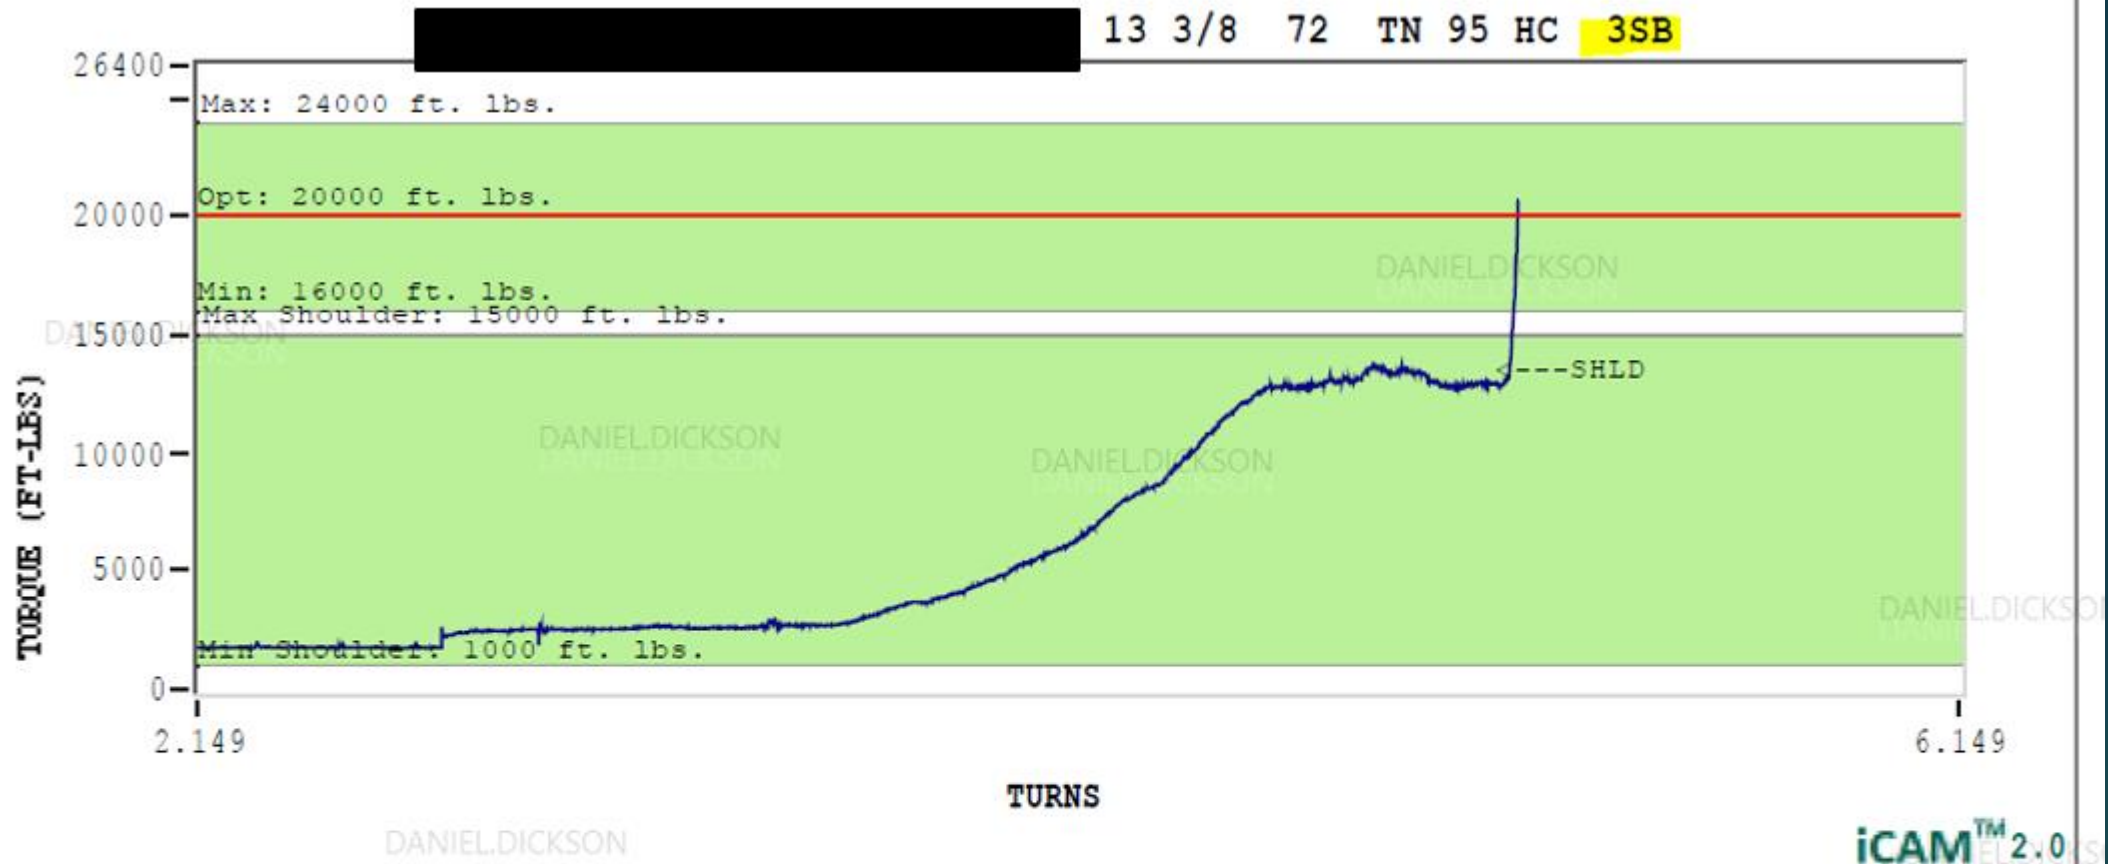
# Joint 61 x 62 2<sup>nd</sup> attempt (Actual)

TIME OF MAKE UP :	05:10 PM	DATE OF MAKE UP :	06/JAN/2023
MAXIMUM TORQUE :	20687 FT-LBS	MAXIMUM TURNS :	5.149 TURNS
SHOULDER TORQUE :	13260 FT-LBS	SHOULDER TURNS :	5.127 TURNS
DELTA TORQUE :	7427 FT-LBS	DELTA TURNS :	0.022 TURNS
FILE NUMBER :	----->> 098	JOINT STATUS :	<b>REJECT</b>

TOP JOINT TALLY # 62; BOTTOM JOINT TALLY # 61; GENERAL COMMENTS: RE MAKUP ; CAM TECH INITIALS: HENDY

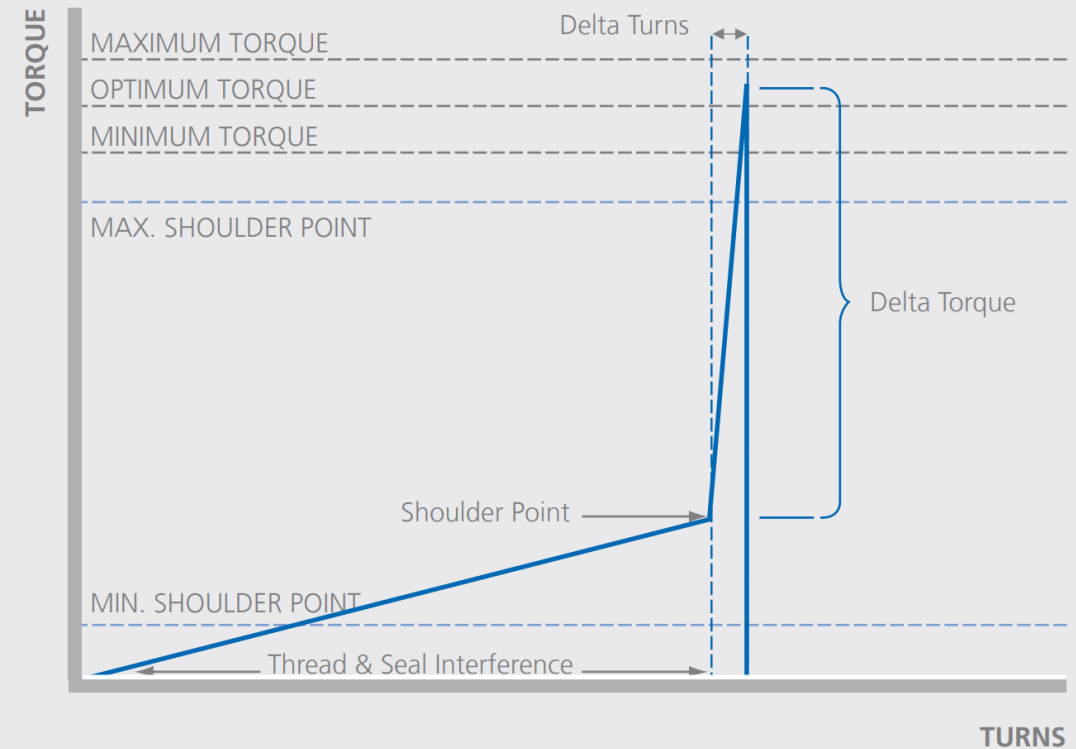
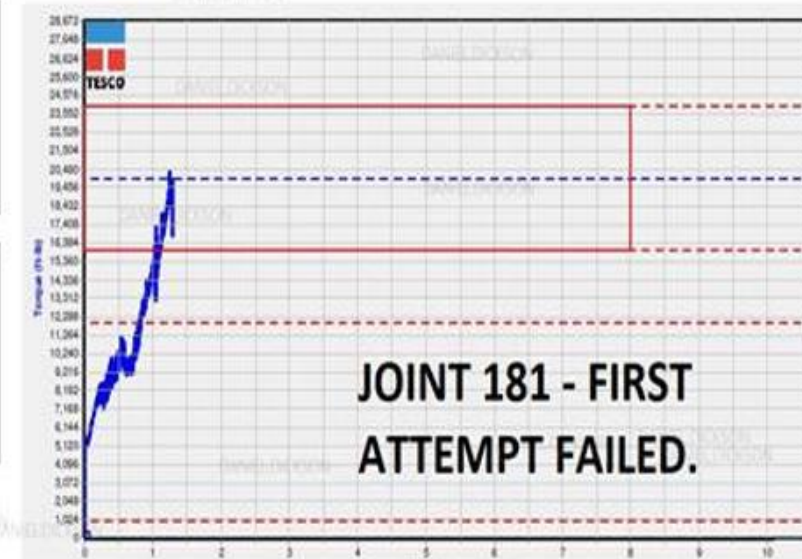
- ▶ Joint 180 was set into the slips
- ▶ Joint 181 was screwed into joint 180 with the CRT.
- ▶ The torque did not make up properly as measured by jam unit.

Client Name
 	Job Location
 	Job Creation
Client Company	
Connection Date	
2022-11-20 12:40:38	
Comment	
FAIL SHLDR

Torque (ft-lb)		
<b>Max Torque</b>	<b>Min Torque</b>	<b>Turns Range</b>
24000.000	16000.000	0.000 - 8.000
<b>Opt Torque</b>	<b>Peak Torque</b>	<b>Turns</b>
20000.000	20342.460	1.248

Shoulder (ft-lb)		
<b>Max Torque</b>	<b>Min Torque</b>	<b>Turns Range</b>
12000.000	1000.000	-4.752 - 1.248
<b>Shldr Torque</b>	<b>Turns</b>	
0.000	0.000

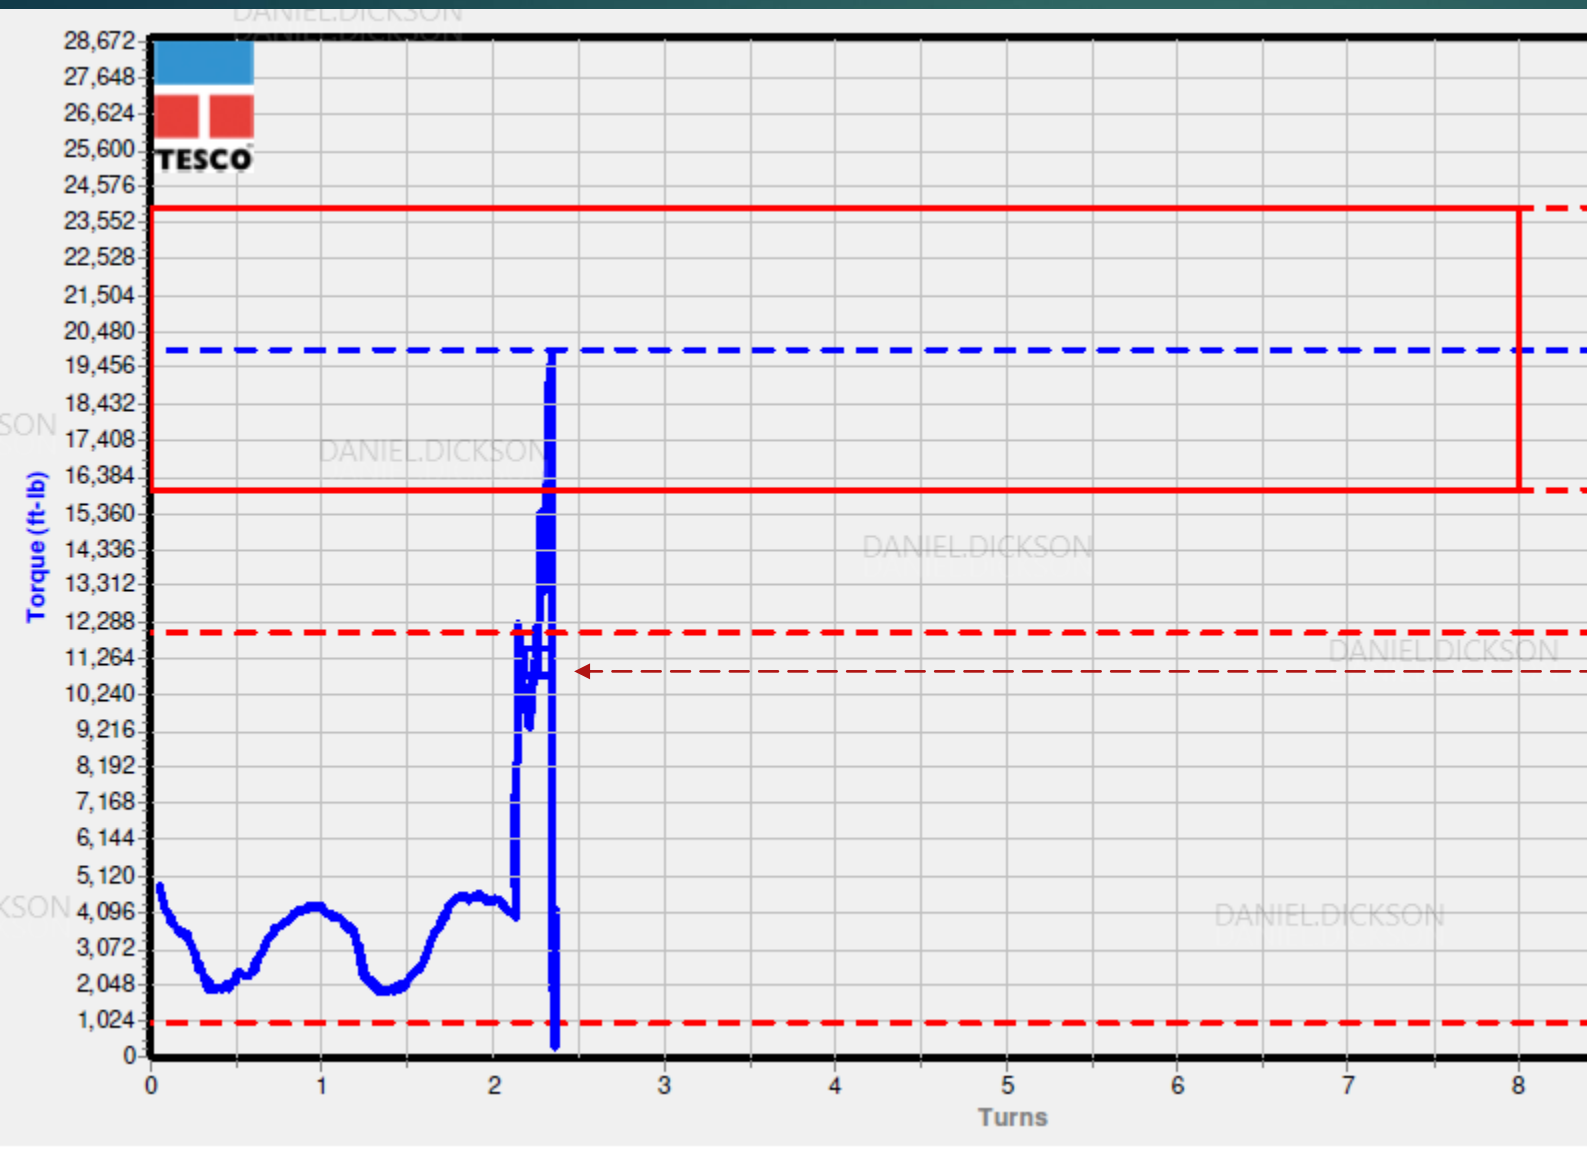
On the rig floor, this spike was attributed to the CRT just re-torquing to where the power tongs first screwed the joint to ~10,000 ftlbs.

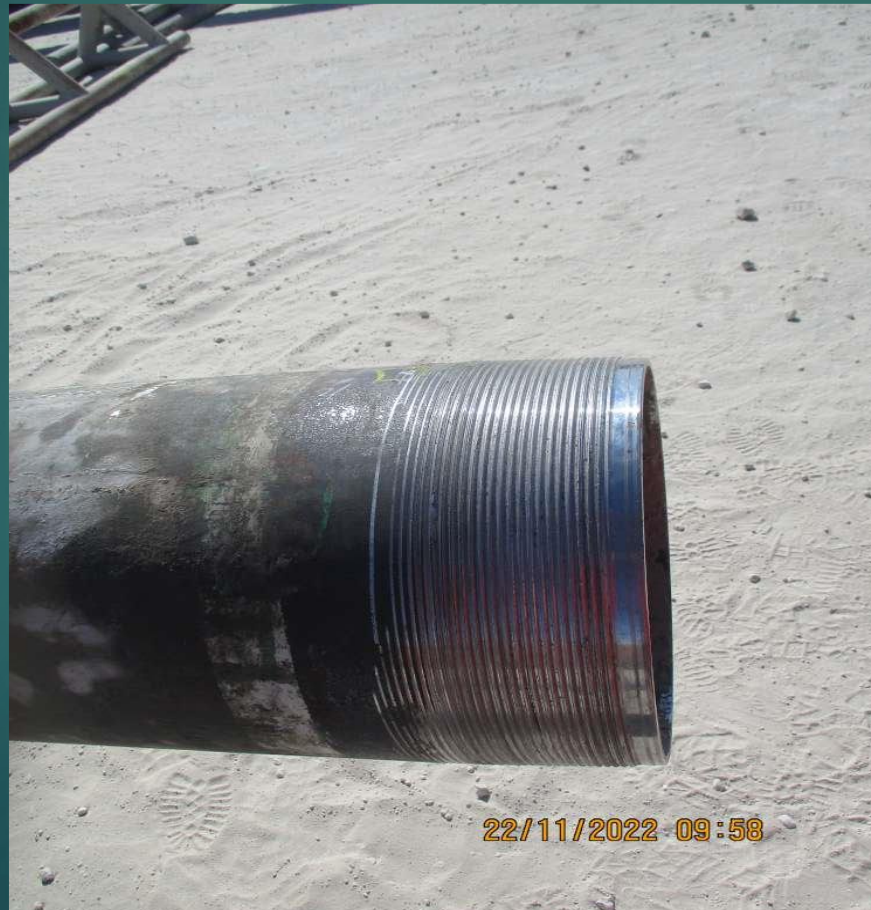
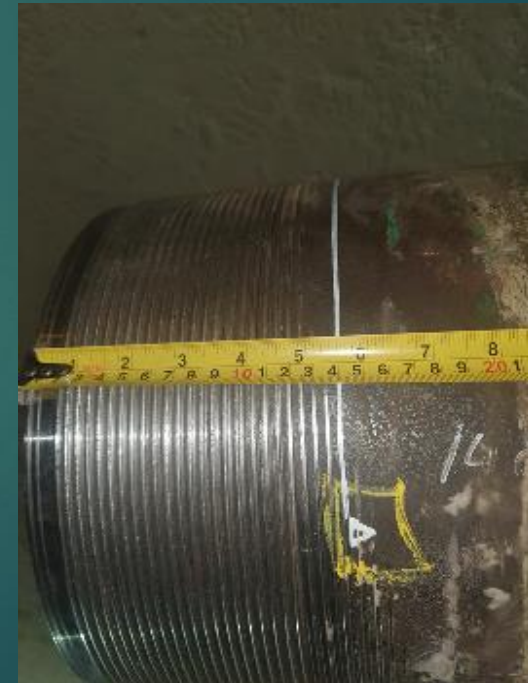
It was observed that several of the casing joints on surface – including joint 181 – did not have the minimum 6.16” of blanking dimension as required by OEM.

- ▶ What does an engineer do to drill down to the root cause?
  - ▶ *Make-up Equipment*
  - ▶ *Casing*

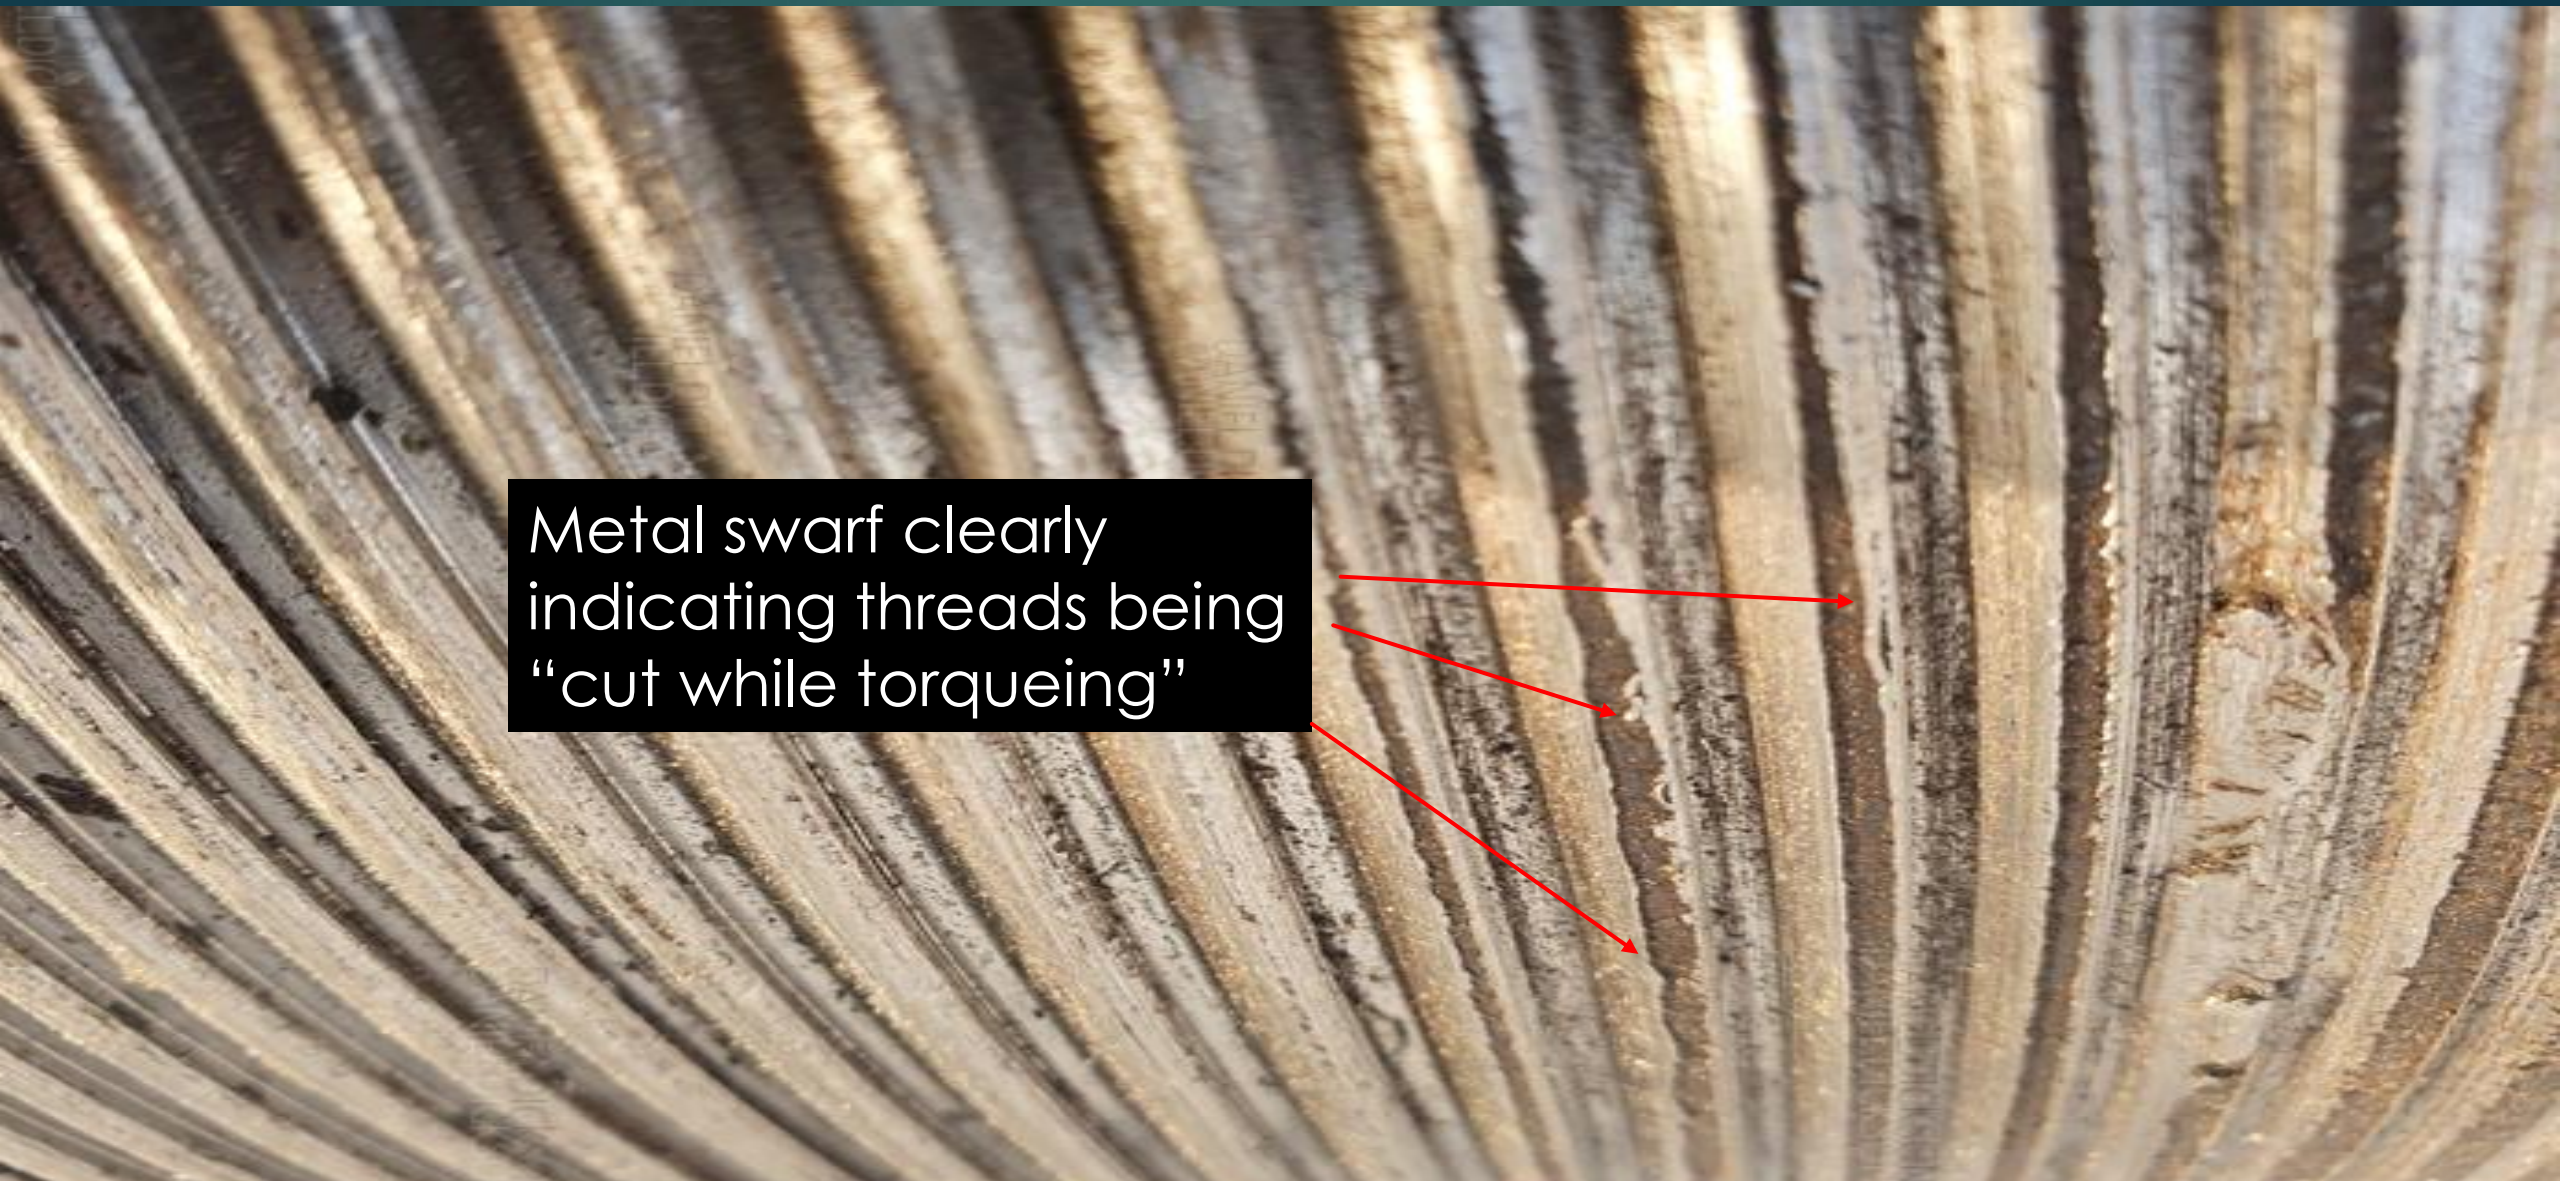
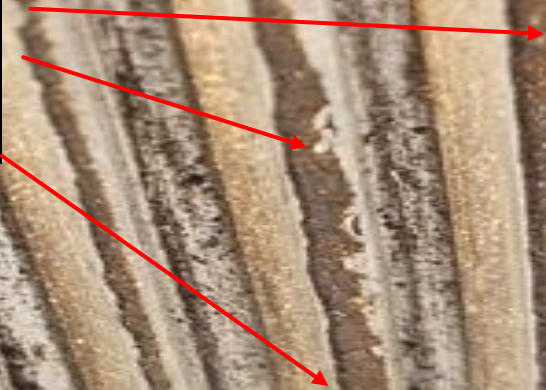
# Picture of Pin 181 close up of threads:

Metal swarf clearly indicating threads being "cut while torqueing"

Several joints – including joint 181 – did not have threads cut to the make-up loss of 5.508”

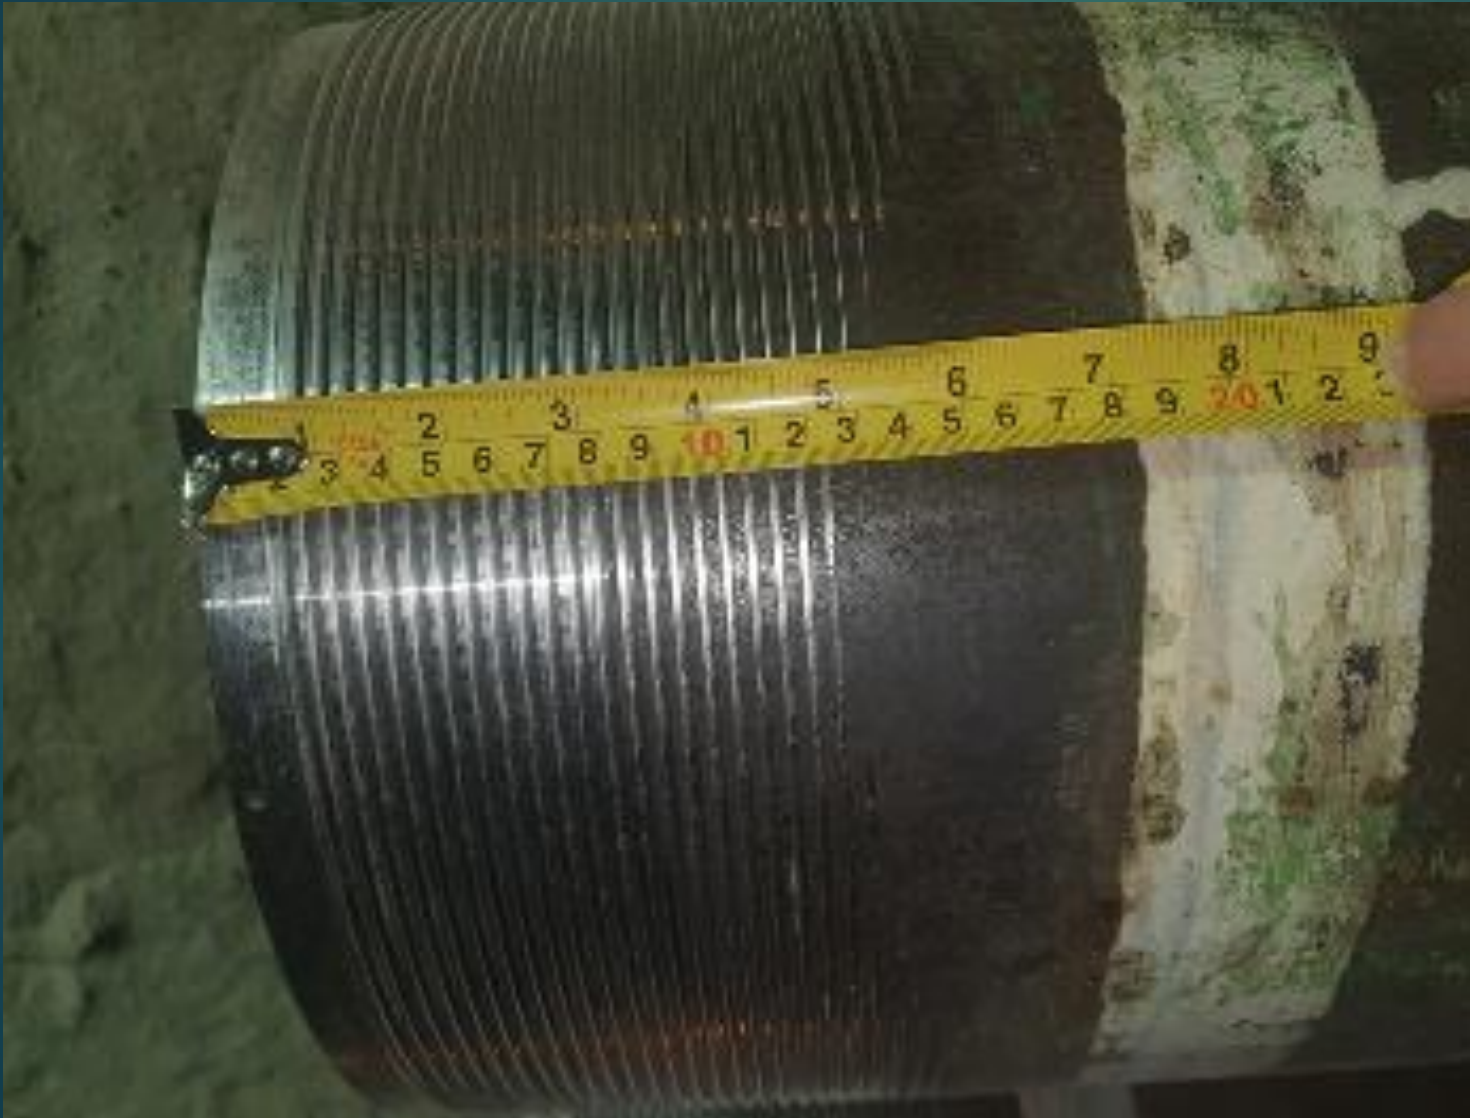
Picture of another joint  
of the same casing:

Only 3 ½" of fully cut  
threads and less than  
5" of *any* threads

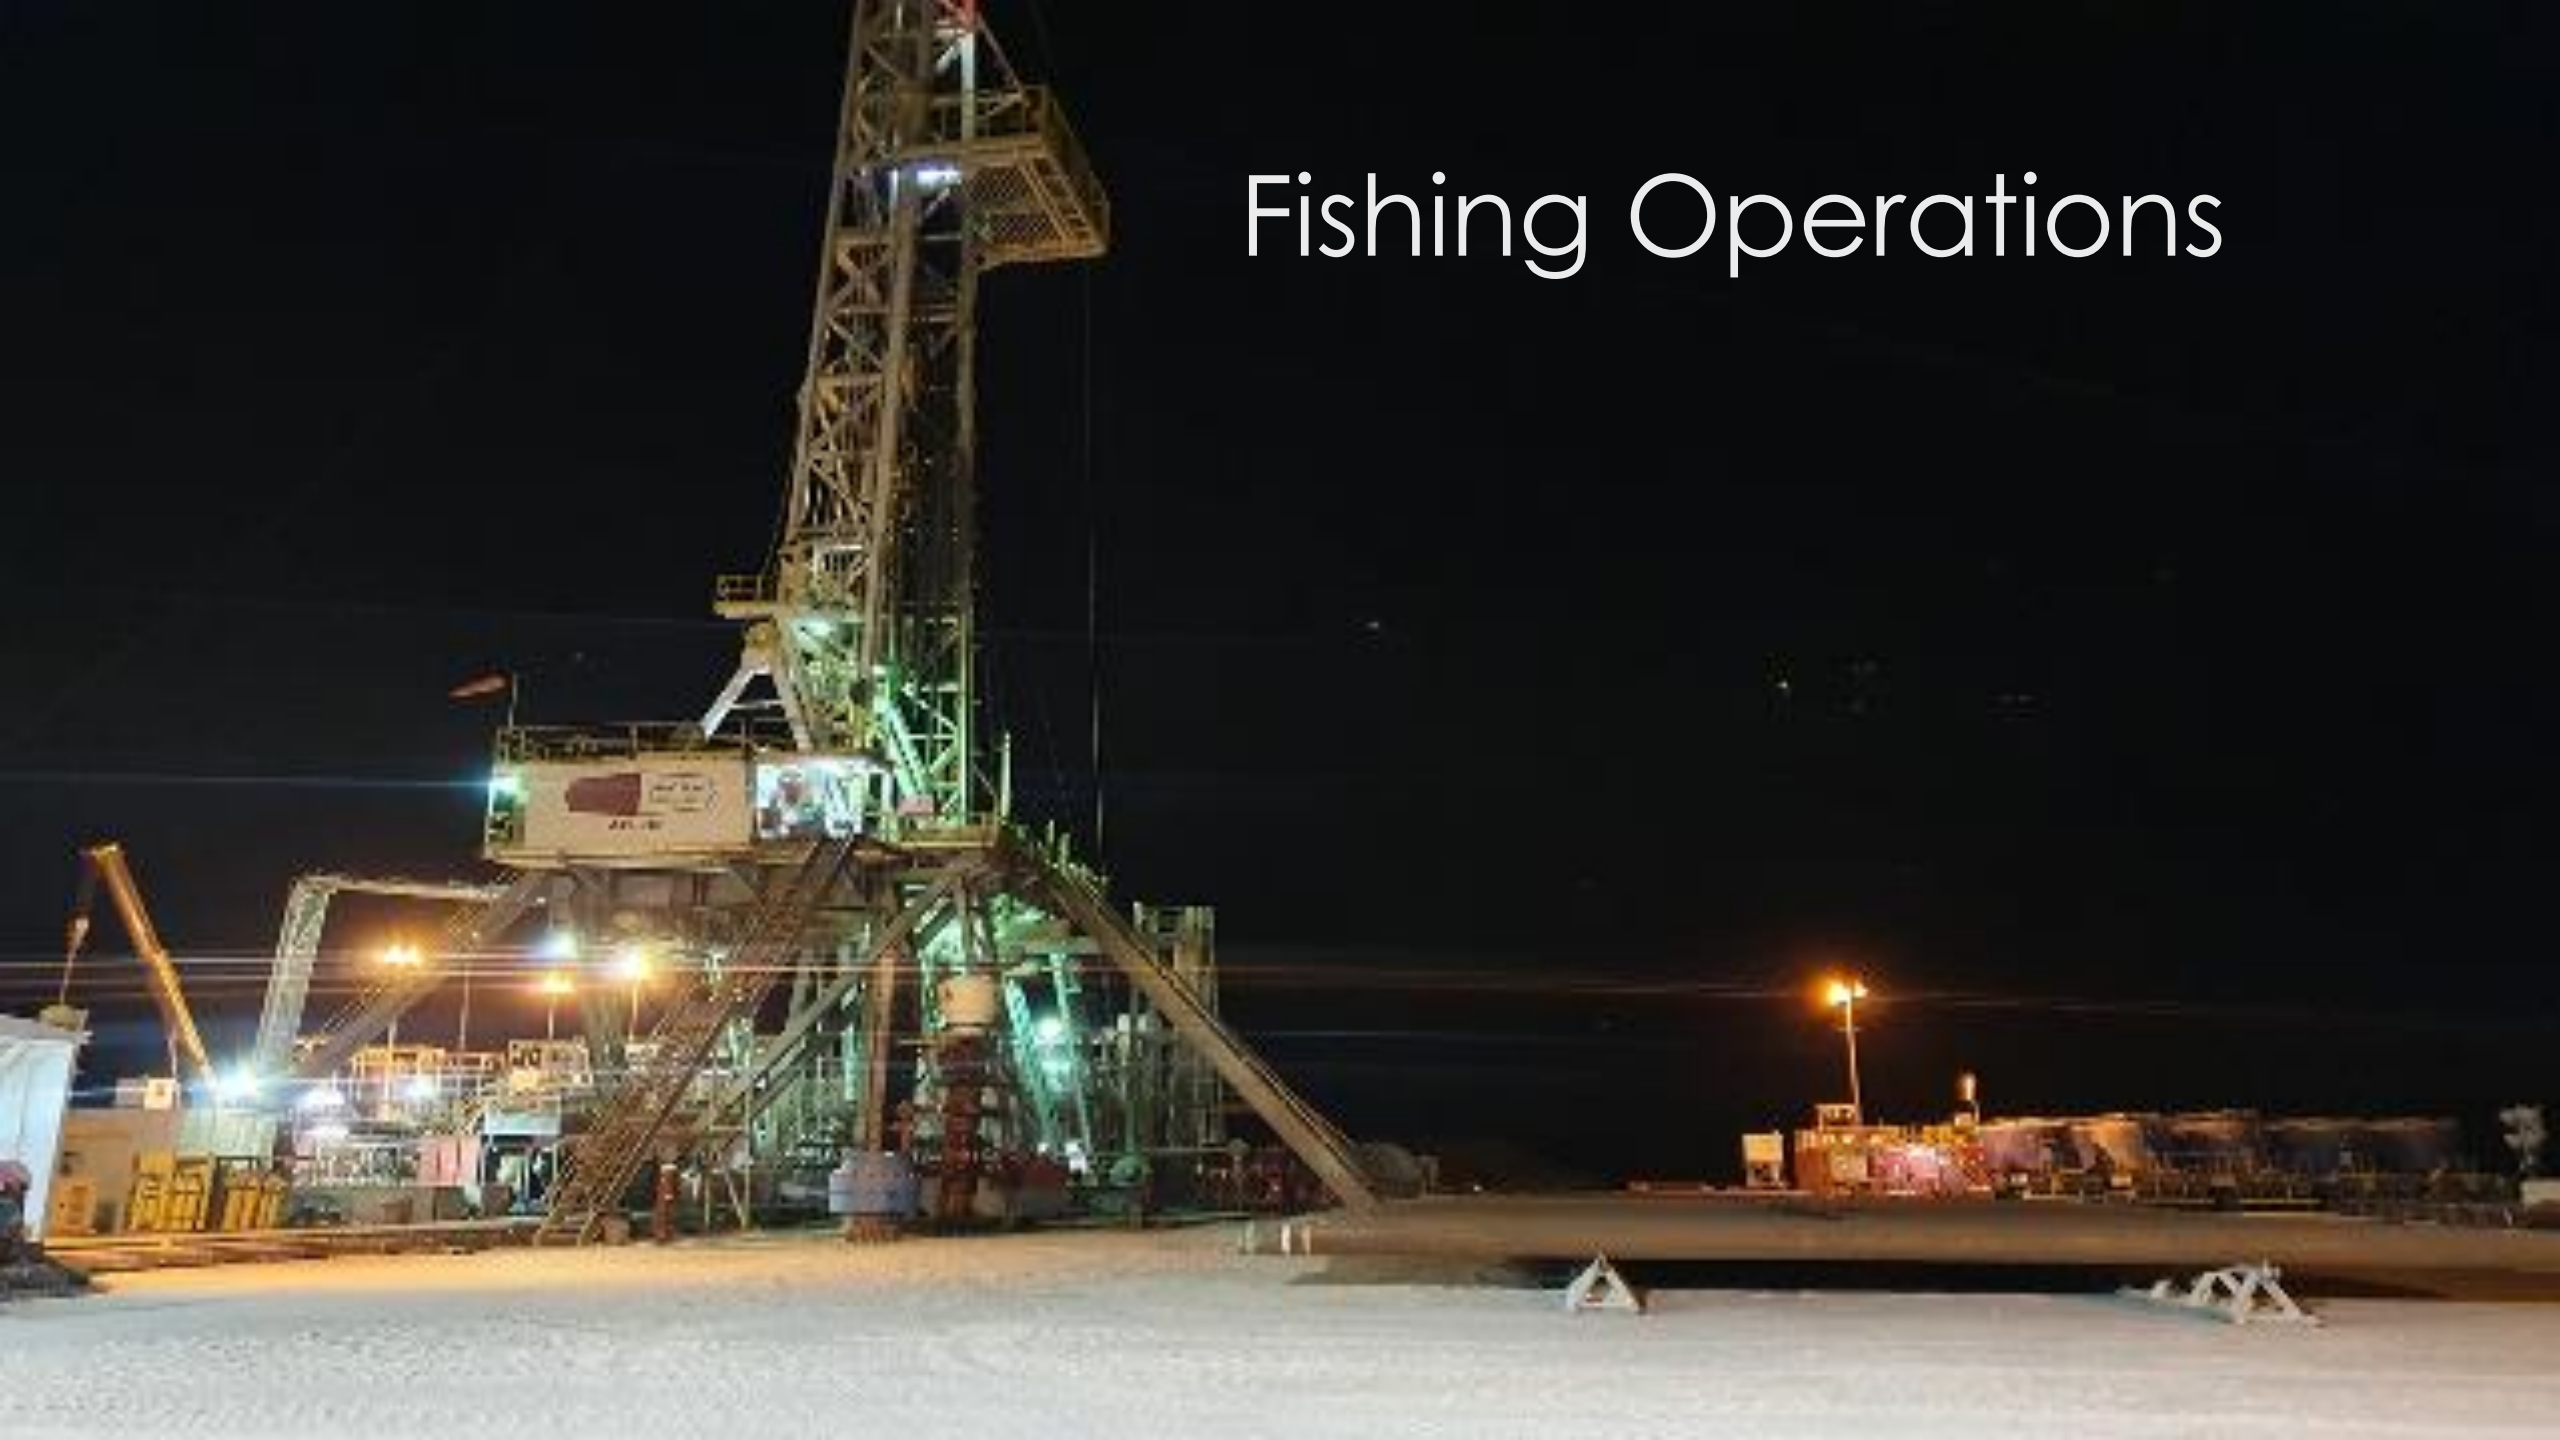
# Fishing Operations

- ▶ 7,443' of casing was dropped in hole.
- ▶ KOP was at 7500' with bottom INC of 35°.
- ▶ Many centralizers were used per cement simulation (137 in open hole)
- ▶ The Weatherford Cementing Stage tool (DV) was already made up into the string and 13 joints from top of fish (top calculated inside previous casing string)
- ▶ The stop collar on the top of the DV tool was our smallest ID (10.25")
- ▶ **There were two open oil production zones with differing pressure profiles – could not be left comingled!**

**When fishing a casing string with a DV tool**, first isolate the tool's slips by cutting and milling before further fishing – ***assume slips have set.***

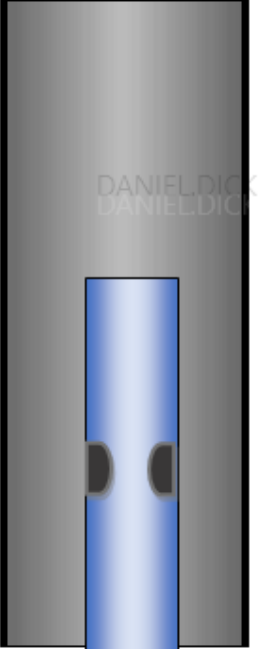
TOF at 3,622' DV at 4,200'	18 5/8" ID = 17.437"	TOF at 3,622' (72#, 3SB threads) DV is 13 joints below TOF ~4,200'
			18 3/8" Shoe 4,533' / 4,533'		DV ID = 10.25"
16"	13 3/8"

KOP at 7500'	13 3/8" 72# = 12.347"	13 3/8" Centralized casing with MANY centralizers
			11,070' / 10,740'	13 3/8" 86# = 12.125"	Bottom hole INC 34.5 degrees at 10,262' Max DLS = 2 degrees
					Fish on bottom

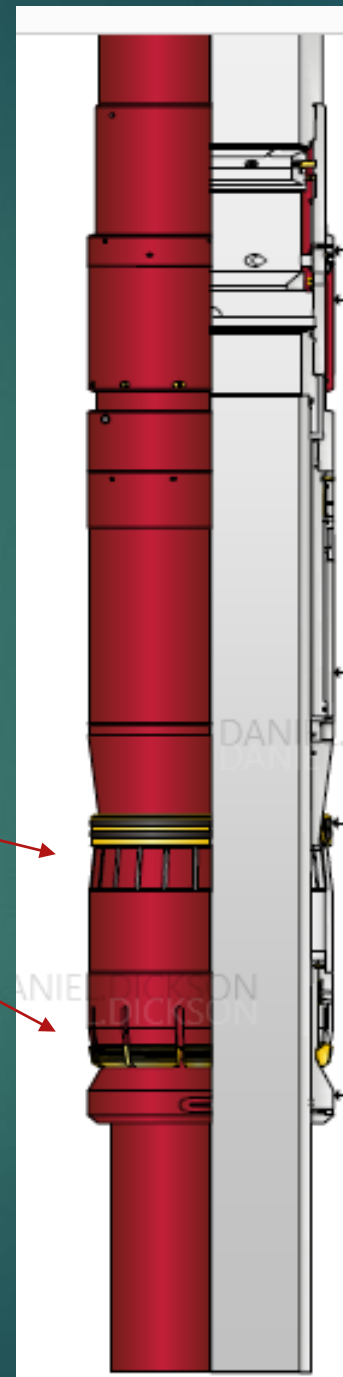
- ▶ The Weatherford Cementing Stage tool (DV) was already made up into the string and 13 joints from top of fish.
- ▶ The DV tool slips are bi-directional, hydraulically set mechanical slips
- ▶ The slips **may** have set from the force of the dropped string

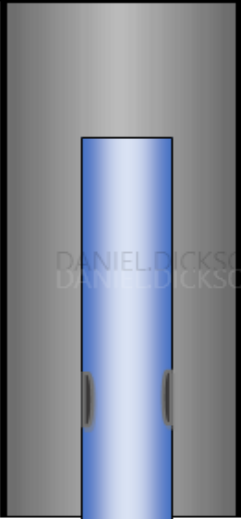
ANDR-1003  
Wellbore Schematic for Fishing Operations, Fishing Run #1 and #2 – Nov 27

TOF at 3,622'	18 5/8" ID = 17.437"	TOF at 3,622' (72#, 3SB threads)
			DV at 4,227'	13 3/8" 72# ID = 12.347"	DV is 13 joints below TOF ~4,227'
			<b>18 3/8" Shoe</b> <b>4,533' / 4,533'</b>	<del>DV ID = 10.25"</del> DV ID milled to 12.25"	
			<b>7361'</b> <b>casing cut #1</b>		<b>First casing cut in</b> <b>Joint 90 at 7361'</b> <b>(blade depth / cut)</b>
16"	13 3/8"

KOP at 7500'	13 3/8" 86# = 12.125"	13 3/8" Centralized casing with MANY centralizers
			<b>11,070' / 10,740'</b>		Bottom hole INC 34.5 degrees at 10,262'
					Max DLS = 2 degrees
					12 1/4" mill run to 10,900' (1 jnt above Baffle)
					Fish on bottom

- ▶ With DV milled out, cutters were run in hole and 13 3/8" casing cut at 7,361' above KOP
- ▶ Spear was RIH and max overpull applied (8-1/4" ITCO Spear with Spear Grapple to catch 13-3/8" Casing - Assy No 9283)
- ▶ Spear suddenly released causing drill line to jump and damaging the rig's deadline anchor – 37 hours of NPT

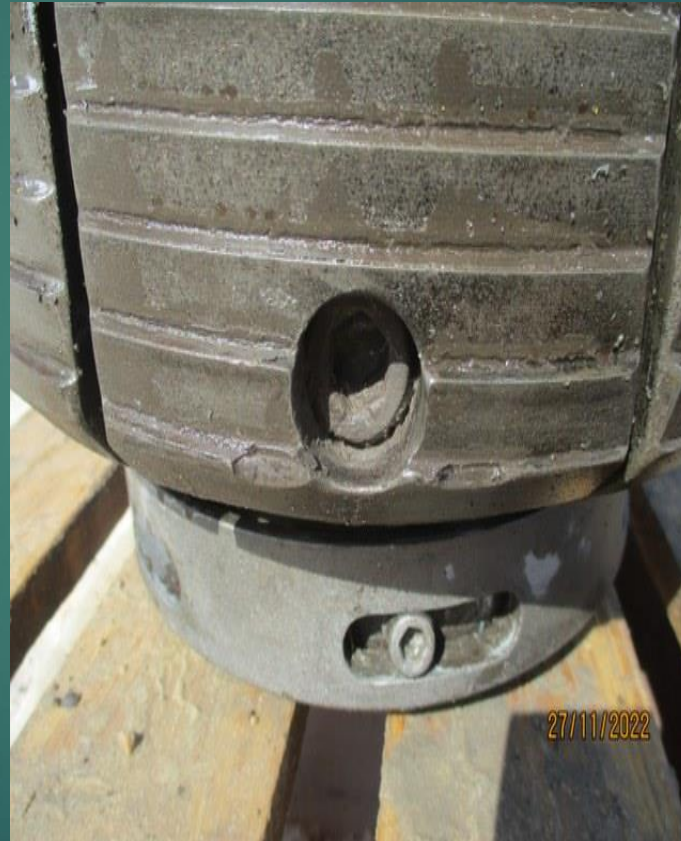
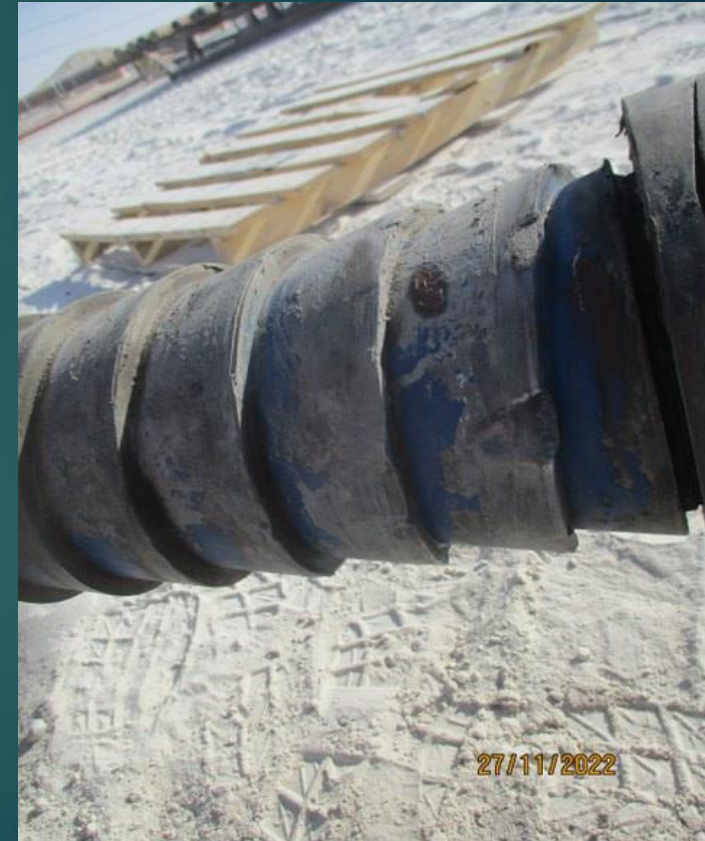
*pictures of spear →*

- ▶ With the rig repaired, a spear was re-run into fish and latched

- ▶ Fish did not pull free
- ▶ Decision made to isolate DV slips
