# Incident review on a major NPT event during casing makeup

DAN DICKSON

APRIL 12, 2024

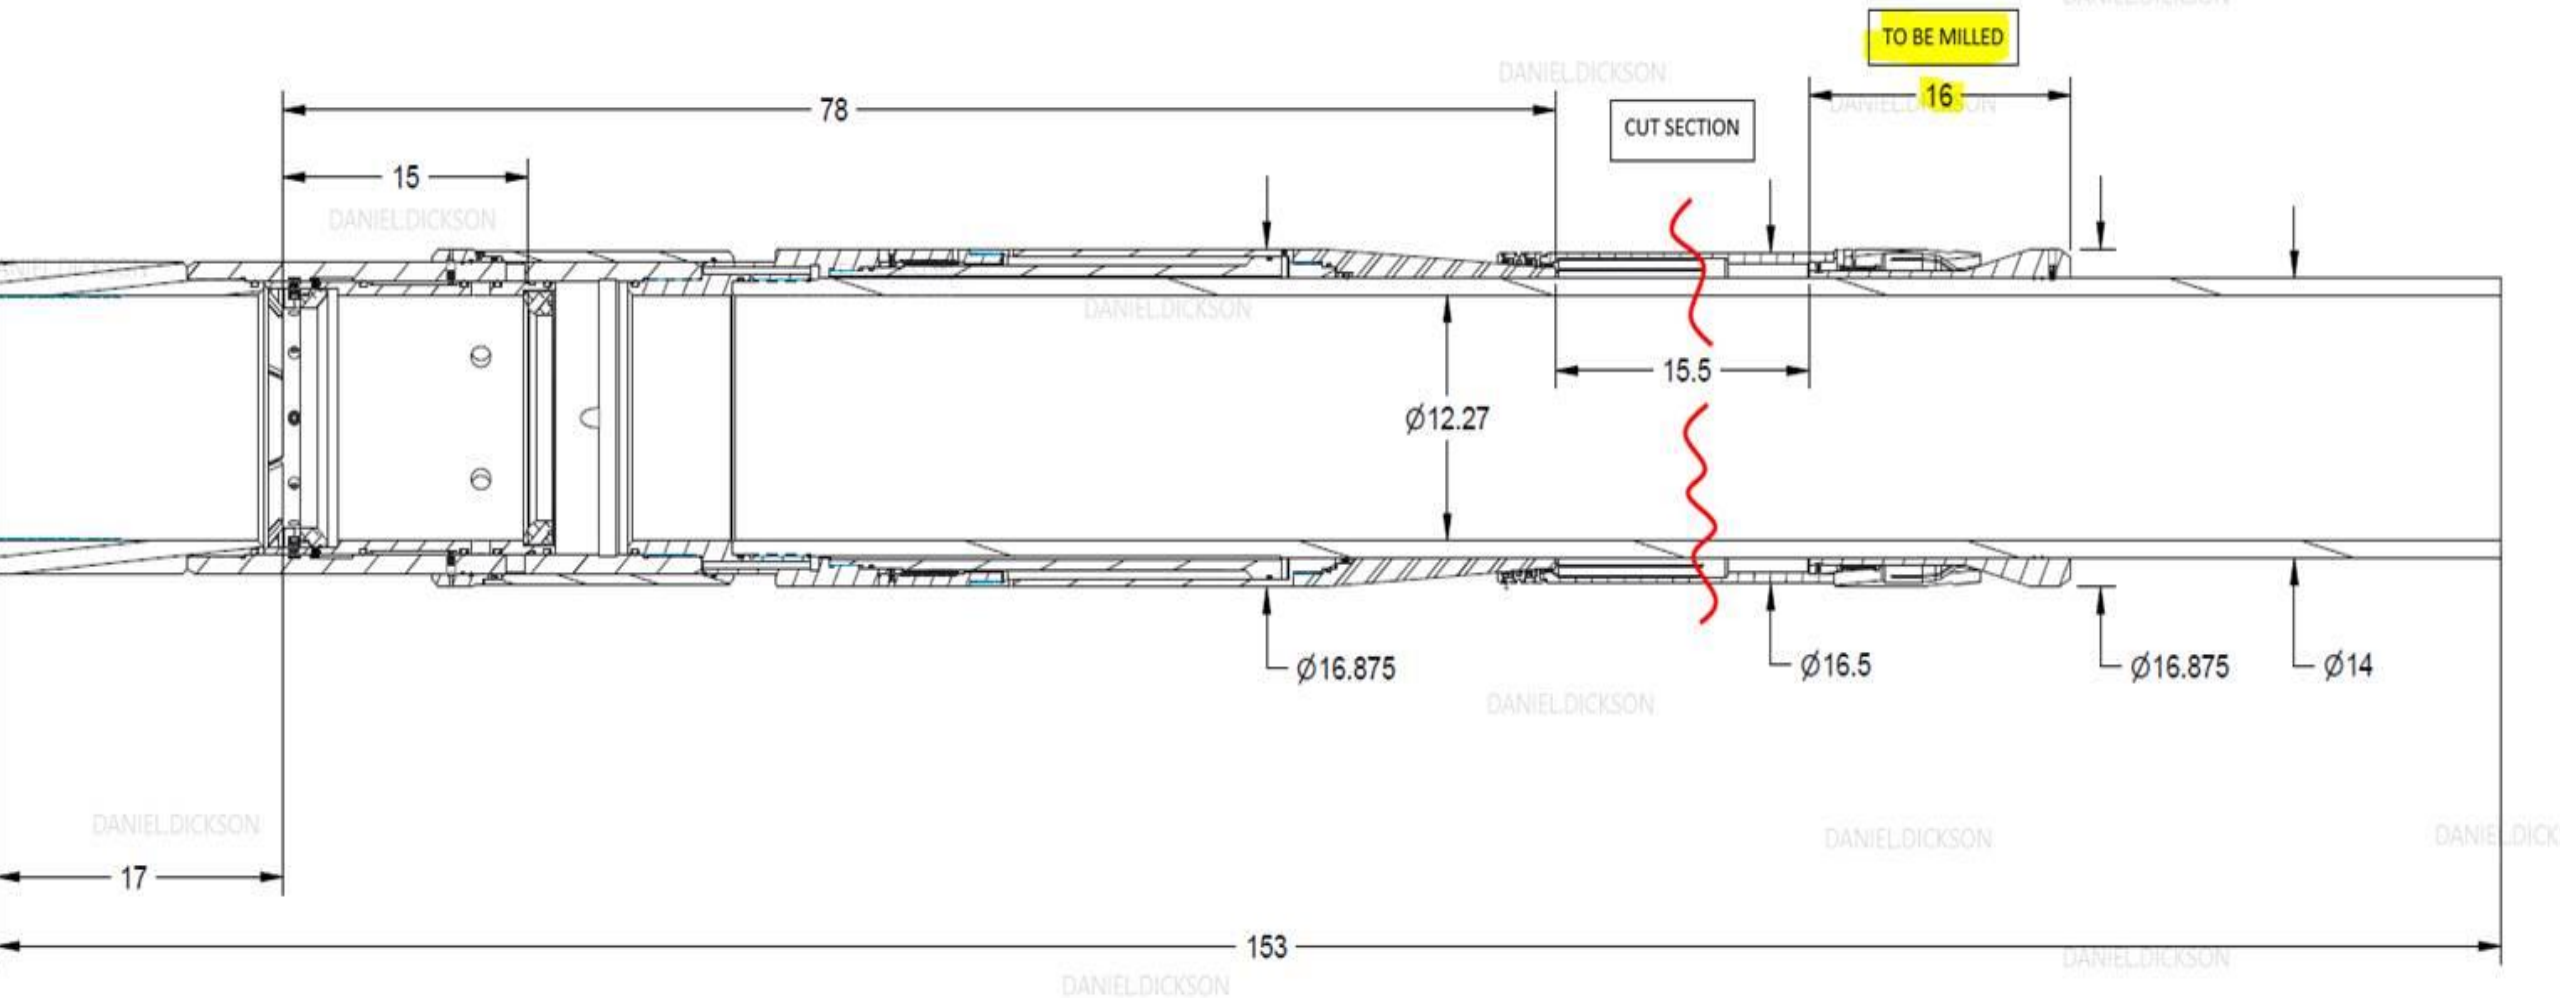
The DV tool required a very precise cut within a 15.5" window:

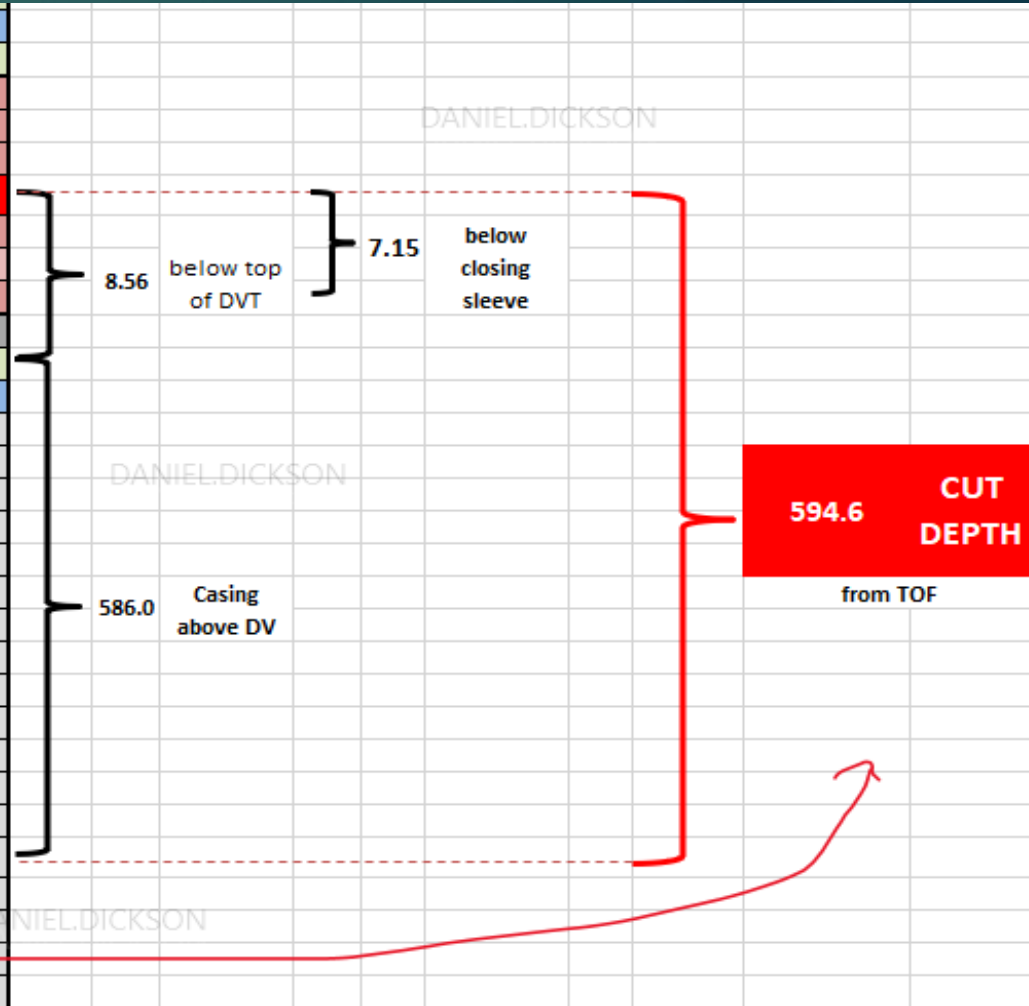
X.O.S (B)	5.68	6839.89	4245.57	4239.88	478157.13	1188.65	72# V.TOP BOX X 72# 3SB PIN	
	Pup joint	5.63	6845.52	4239.88	4234.26	478495.94	1189.62	72# AM-HBC BARE PJ	BOW
W F D	lower tool	3.03							
	DV slips	1.25							
		lower cut limit	7.79	4231.25				from closing sleeve	
	<b>CUT HERE</b>		<b>7.15</b>	<b>4230.60</b>				<b>from closing sleeve</b>	
		upper cut limit	6.50	4229.96				from closing sleeve	
D V T	opening seat	1.25							
	closing sleeve	1.42		4223.46					
	WFD DVT (tally)	12.22	6857.74	4234.26	4222.04	479231.99	1191.75	WFD 5K DVT	
	Pup joint	11.70	6869.44	4222.04	4210.34	479936.71	1193.78	72# AM-HBC BARE PJ	BOW
	X.O.S @	5.74	6875.17	4210.34	4204.60	480282.15	1194.78	72# V.TOP PIN X 72# 3SB BOX	
1	joint no# 167	40.57	6915.74	4204.60	4164.03	482725.85	1201.83	72# 3SB BARE CSG	BOW 41.03
2	joint no# 168	40.62	6956.36	4164.03	4123.41	485172.57	1208.89	72# 3SB BARE CSG	BOW 41.08
3	joint no# 169	39.37	6995.73	4123.41	4084.04	487544.00	1215.73	72# 3SB BARE CSG	BOW 39.83

THIS TALLY MEASURES THE STRING FROM TOF.

ENTER TOF TAG DEPTH AND THE OTHER DEPTHS WILL BE CALCULATED.

NOTE - WE HAVE LOST 7' OF STRING LENGTH AFTER THE DROP..... (FROM TD TO TOF)

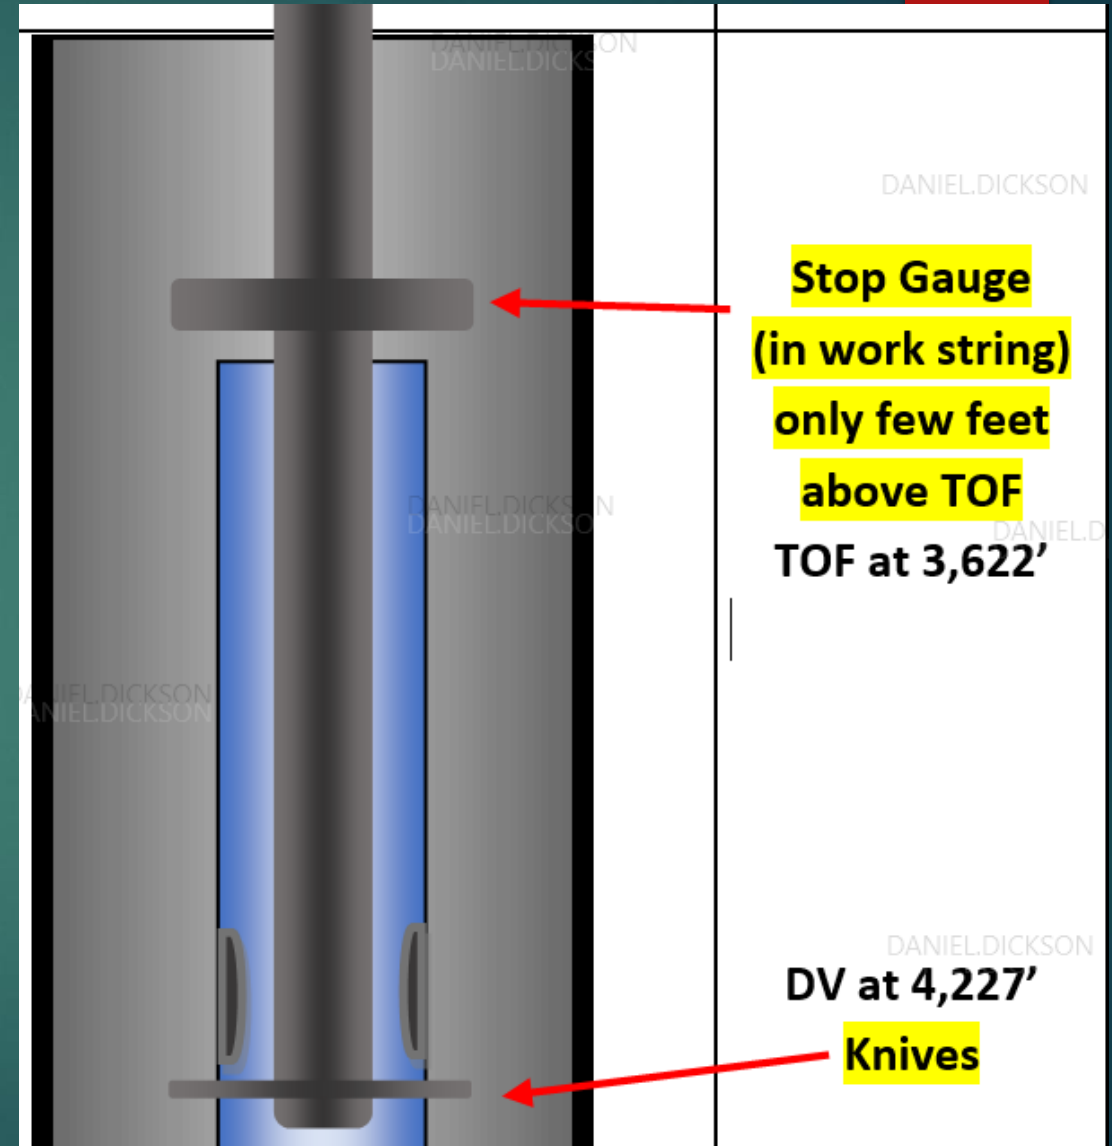
4,227' to Top of DV provides too much depth to confirm accurate cut

How we verified precise cut depth:

- 1) Tally length above DV is known
- 2) DV dimensions are known
- 3) Added a stop gauge into fishing string a few feet above TOF length.
- 4) RIH with cutters until stop gauge tagged TOF
- 5) Pulled up exact amount to place cutters in precise window

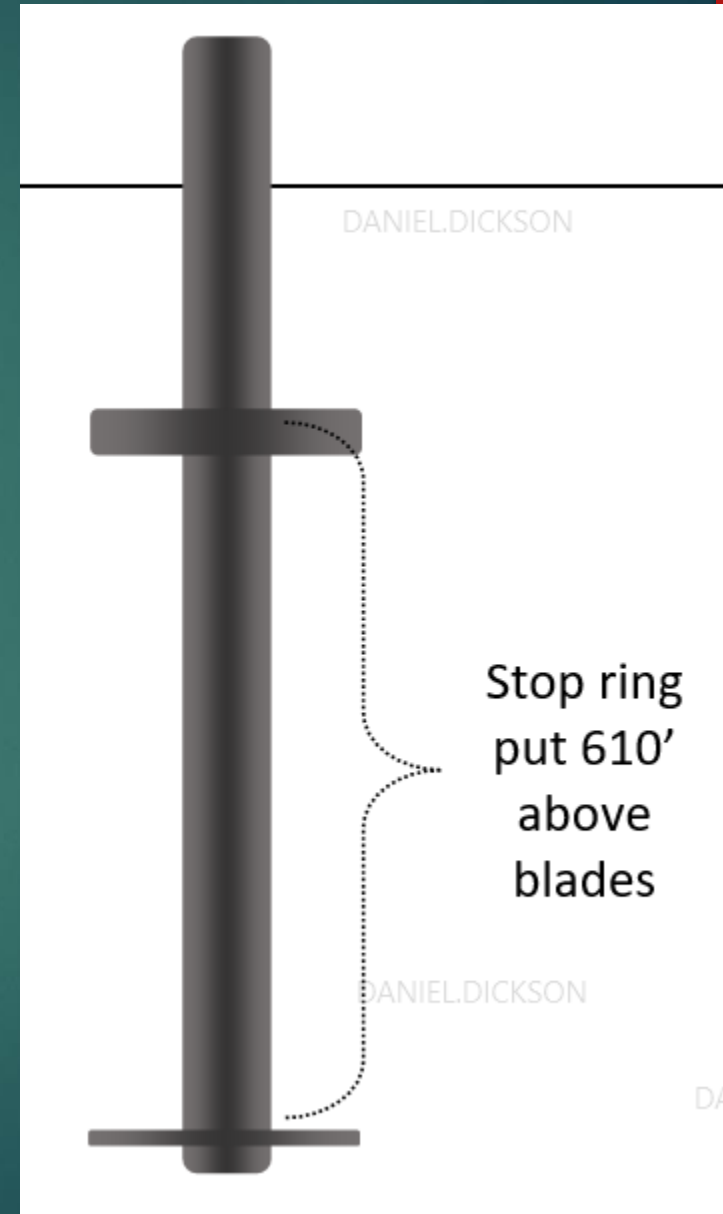
3) Stop gauge (large OD) put into work string at 610' above cutting blades

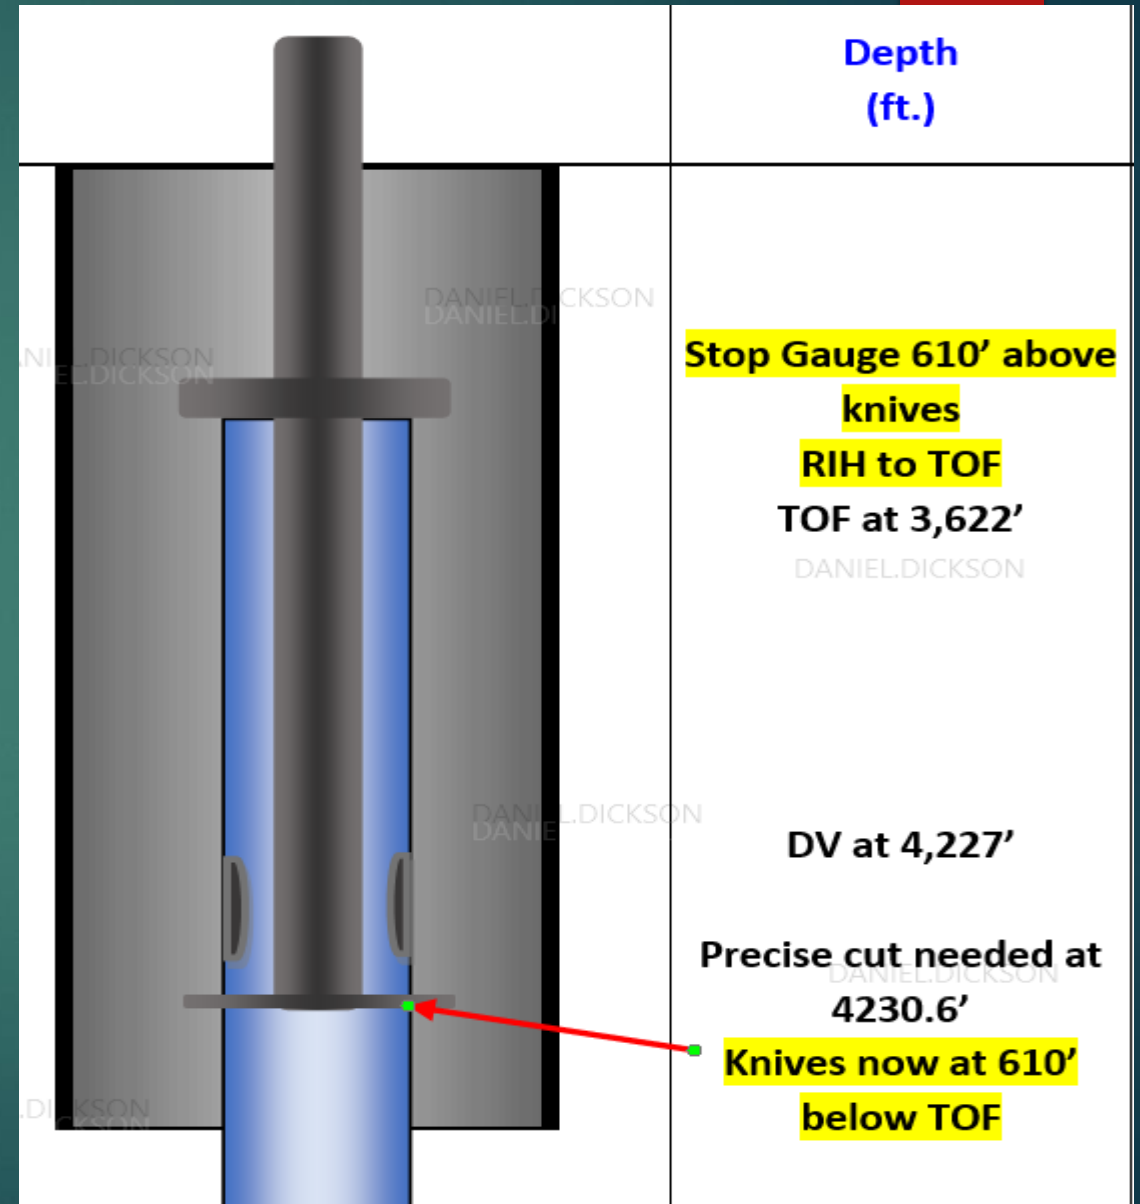
4) RIH with cutters until stop gauge tagged TOF.

At this point we can verify the knives are 610' below TOF.

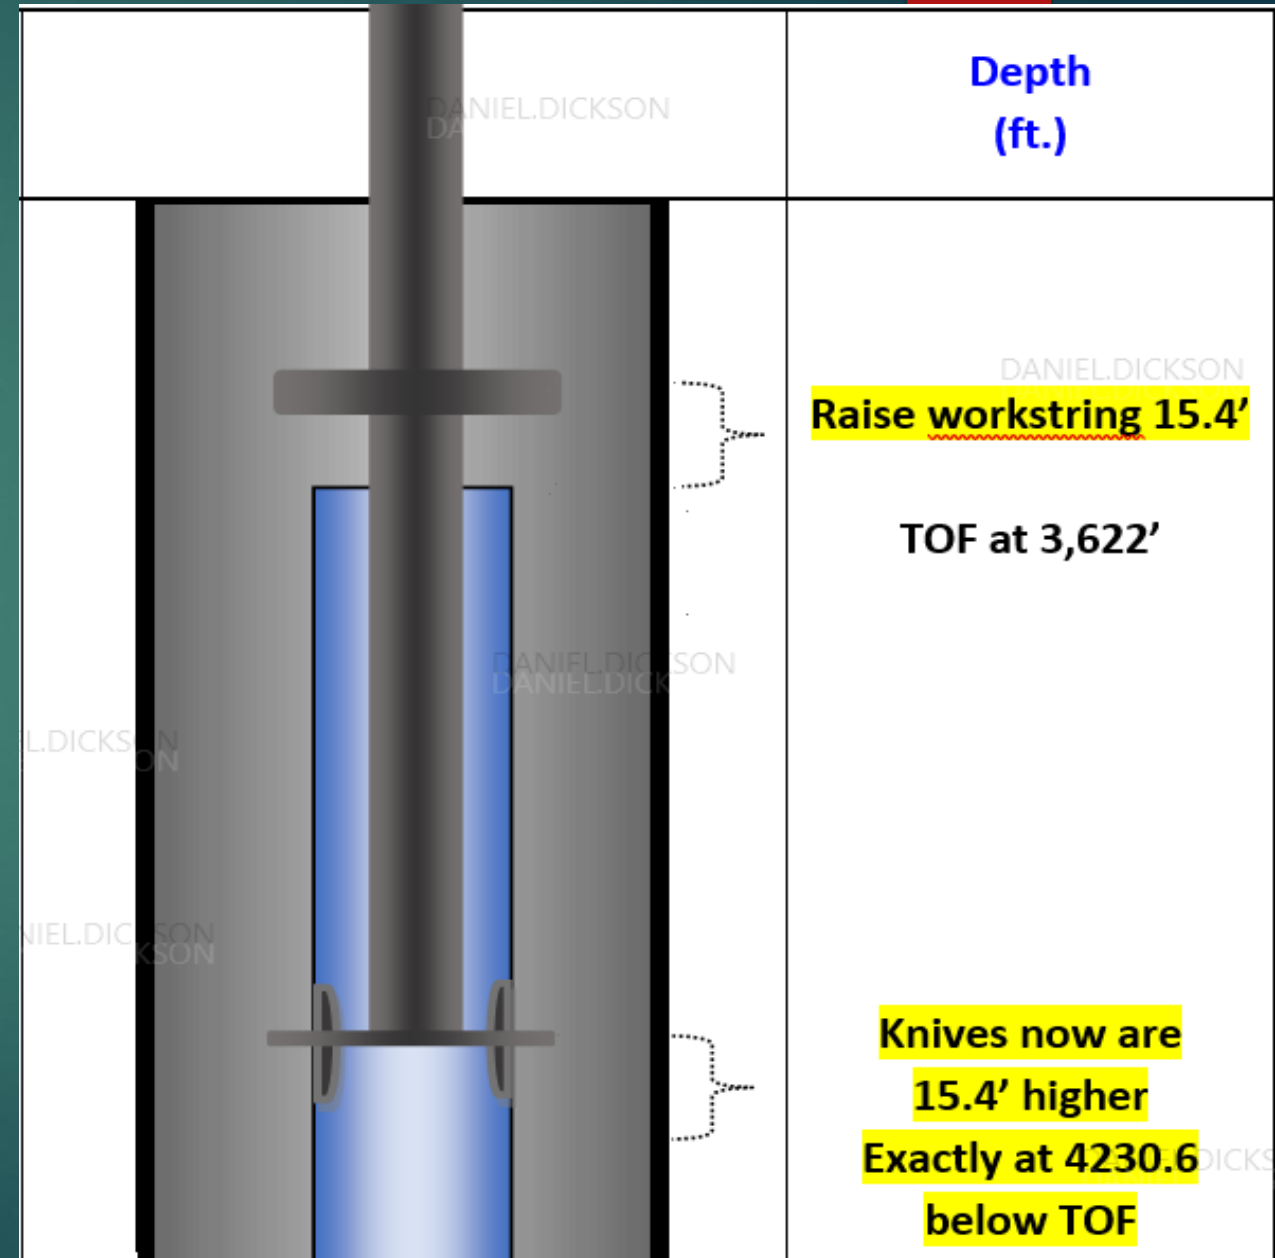
5) Pulled up exact amount to place cutters in precise window

The work string was pulled up a few feet (measured on pipe at rotary table) to verify exact cut depth as per the casing tally.

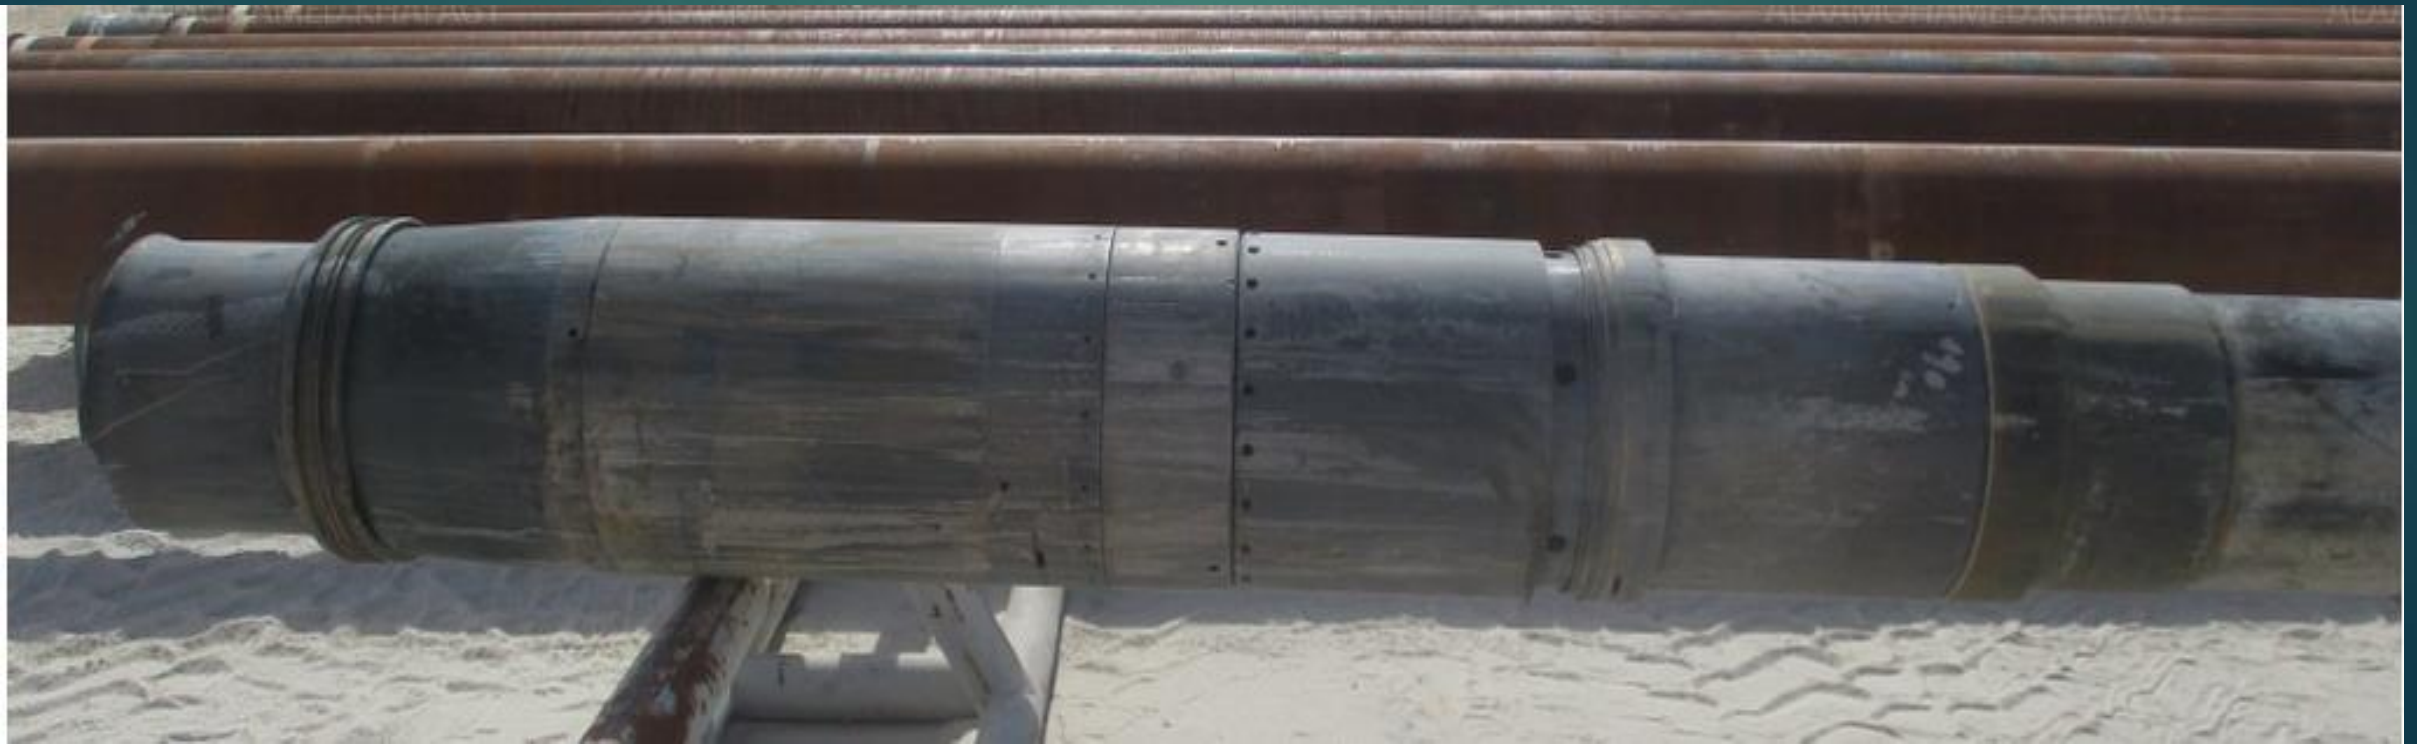
Cutters were POOH and a spear RIH to recover casing & top of DV.

Fish recovered successfully:

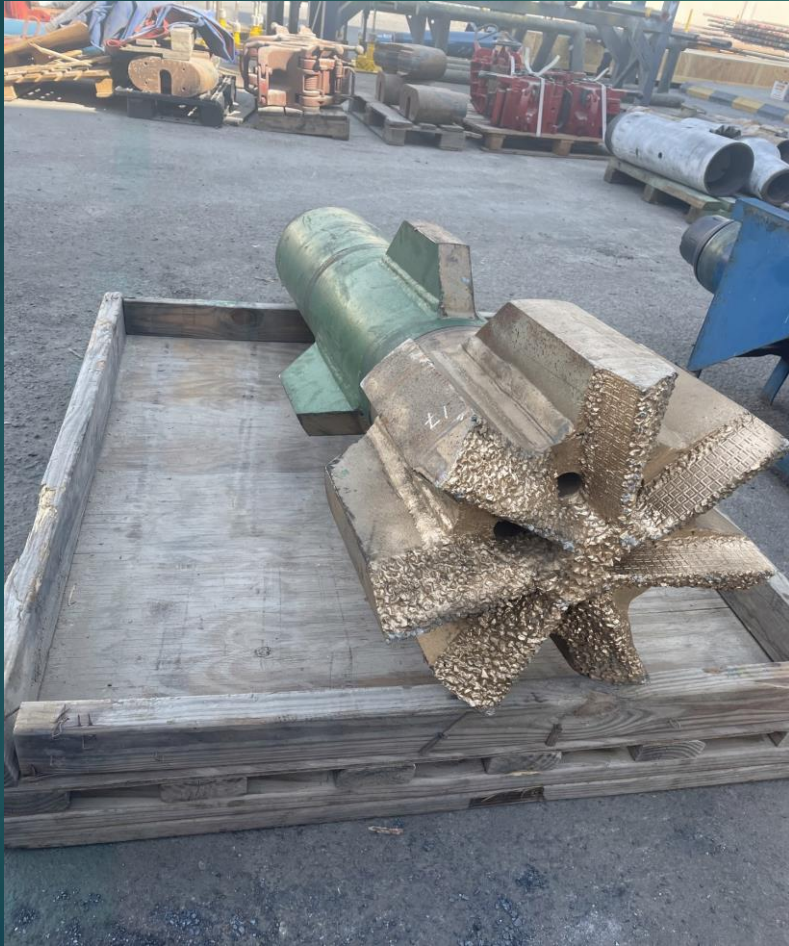
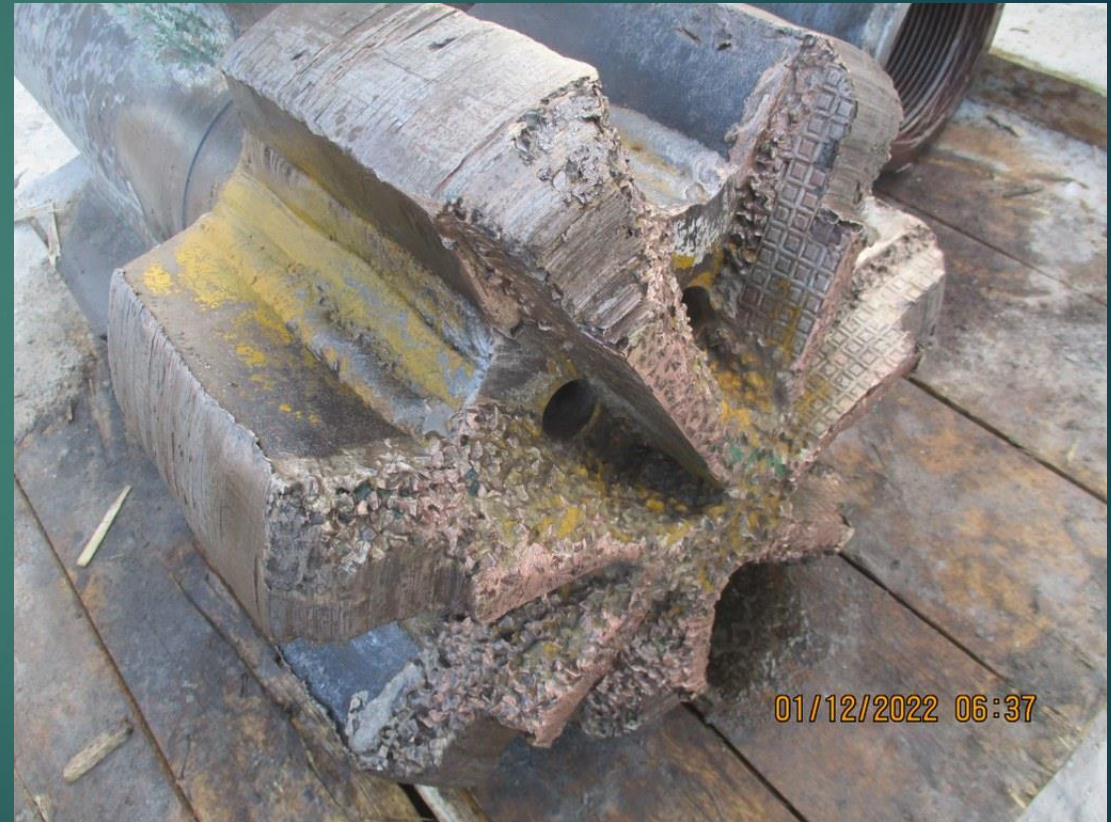
17 1/2" bladed junk mill was RIH to remove the DV slips.

Total of three feet was milled.

17 ½" bladed junk mill new versus after milling:

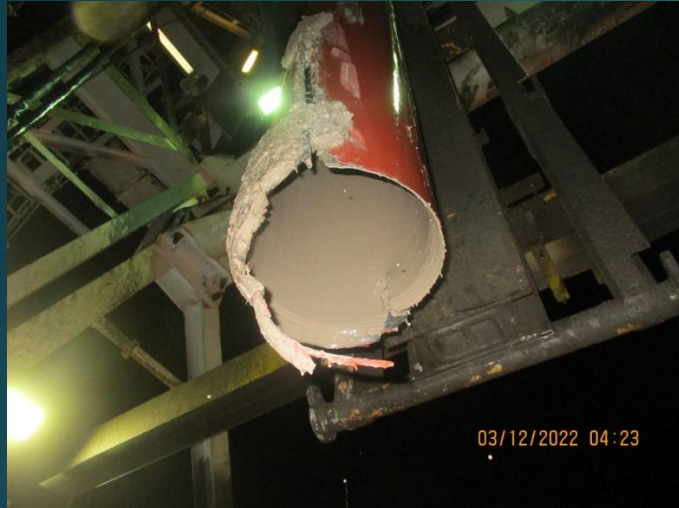
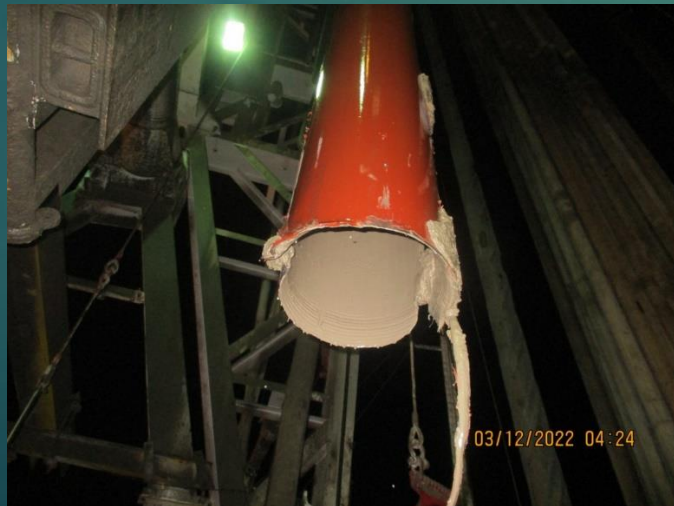
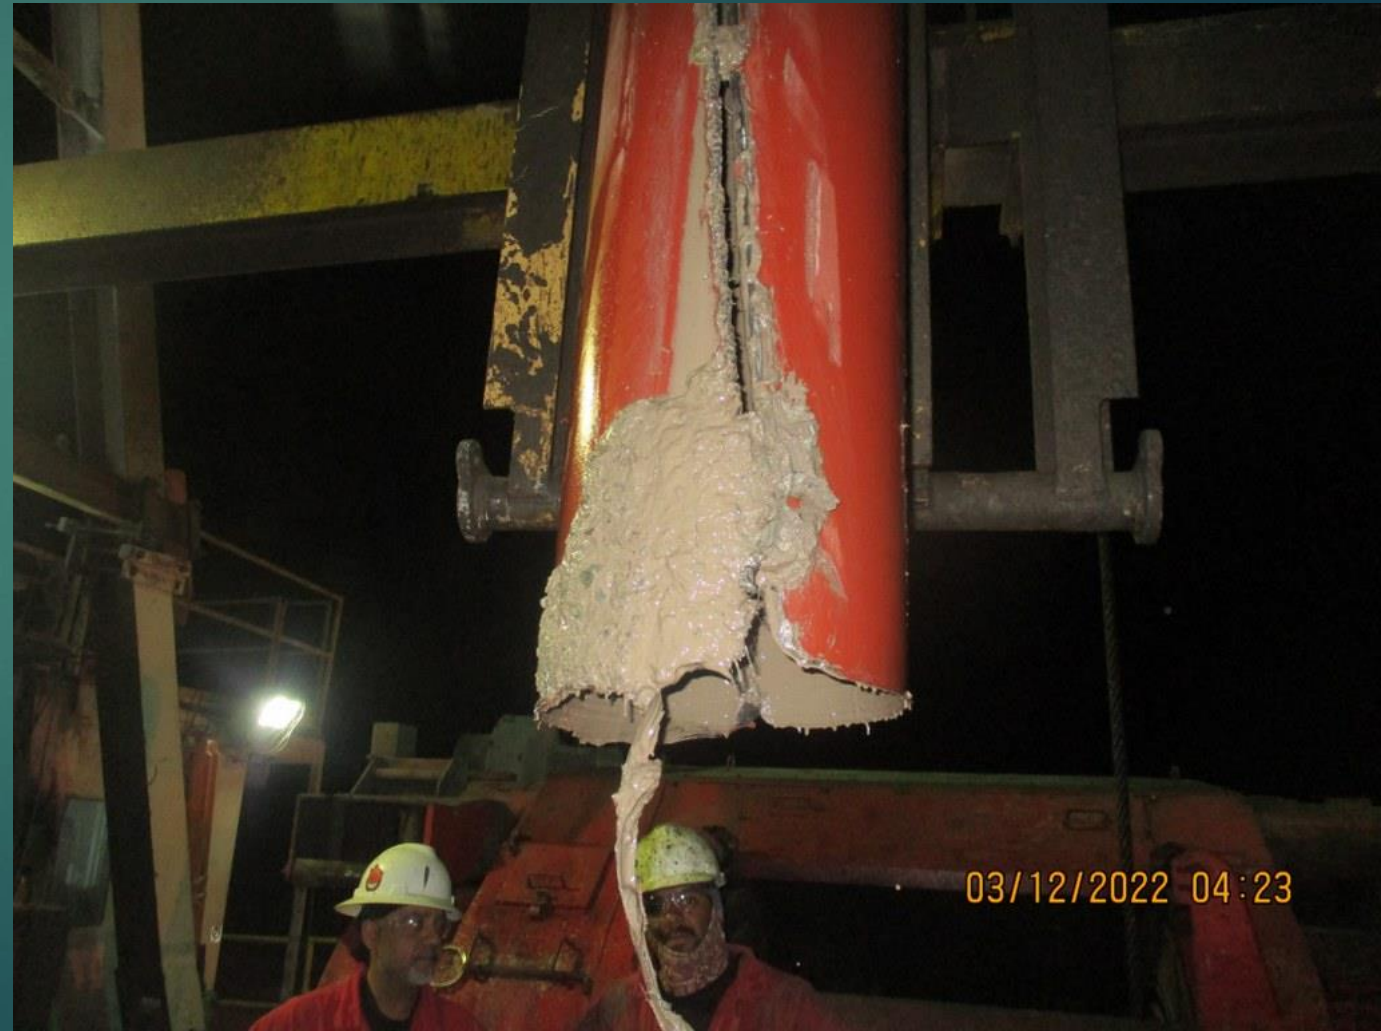
Pictures of recovered casing showing the initial casing cut at 7,361'

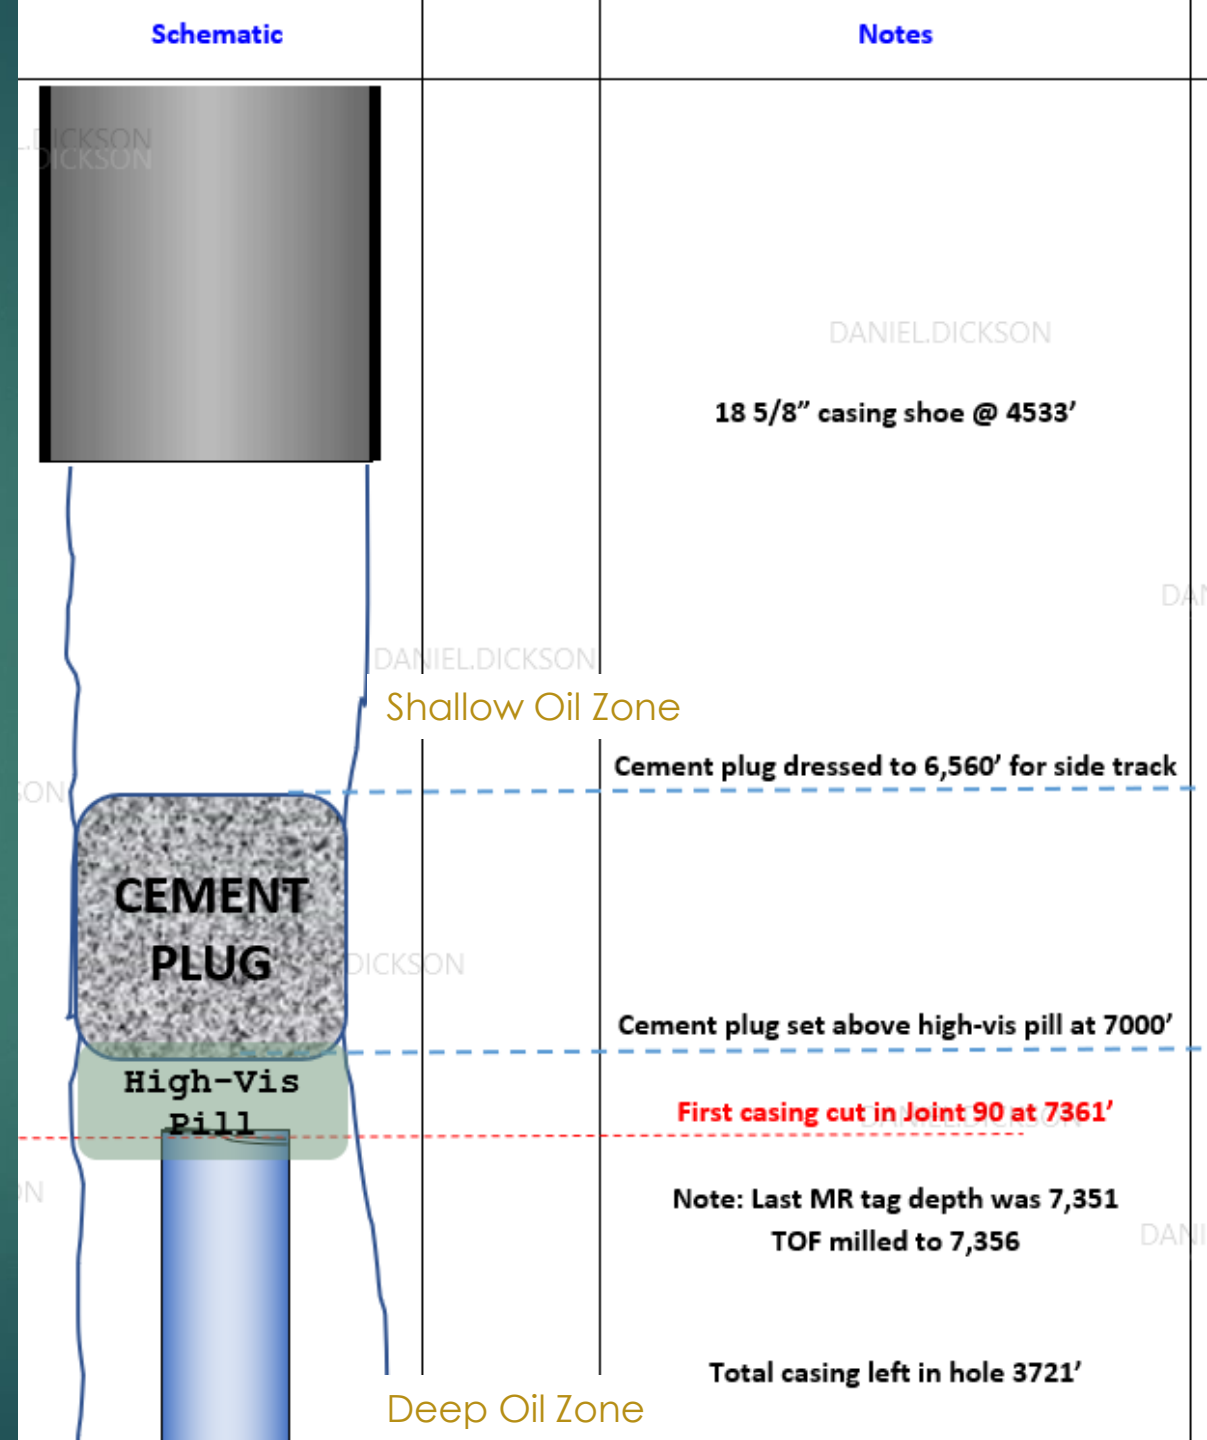
Two more spearing attempts and a run to dress the TOF with a mill were conducted.

The lower casing section was not recovered and a decision to sidetrack the well was made.

Lower section abandoned and re-drilled with OH whipstock.

By pulling the upper casing section we were able to maintain subsurface integrity by isolating the various hydrocarbon zones.
